Licensee	Perilya Broken Hill Limited (PBHL)
Address	Wentworth Rd, Broken Hill, NSW, 2880.
Reporting period	June 2020

Meteorological Summary

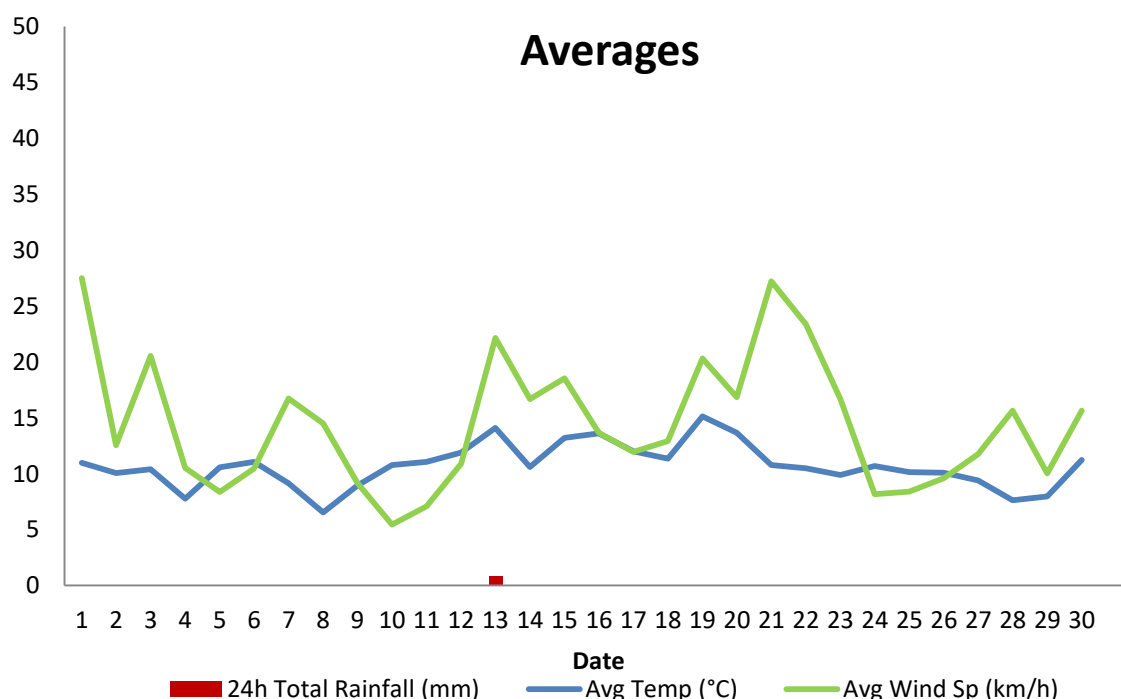
Figure 1. Average wind speed (km/hr) and daily rainfall (mm) for June 2020.

Daily average temperature and wind speed data for June 2020 is presented in Figure 1 and provides context to the trends observed in the high volume air sampler (HVAS) and the standard dust deposition gauges (SDDG). The prevailing wind direction for June 2020 was West.

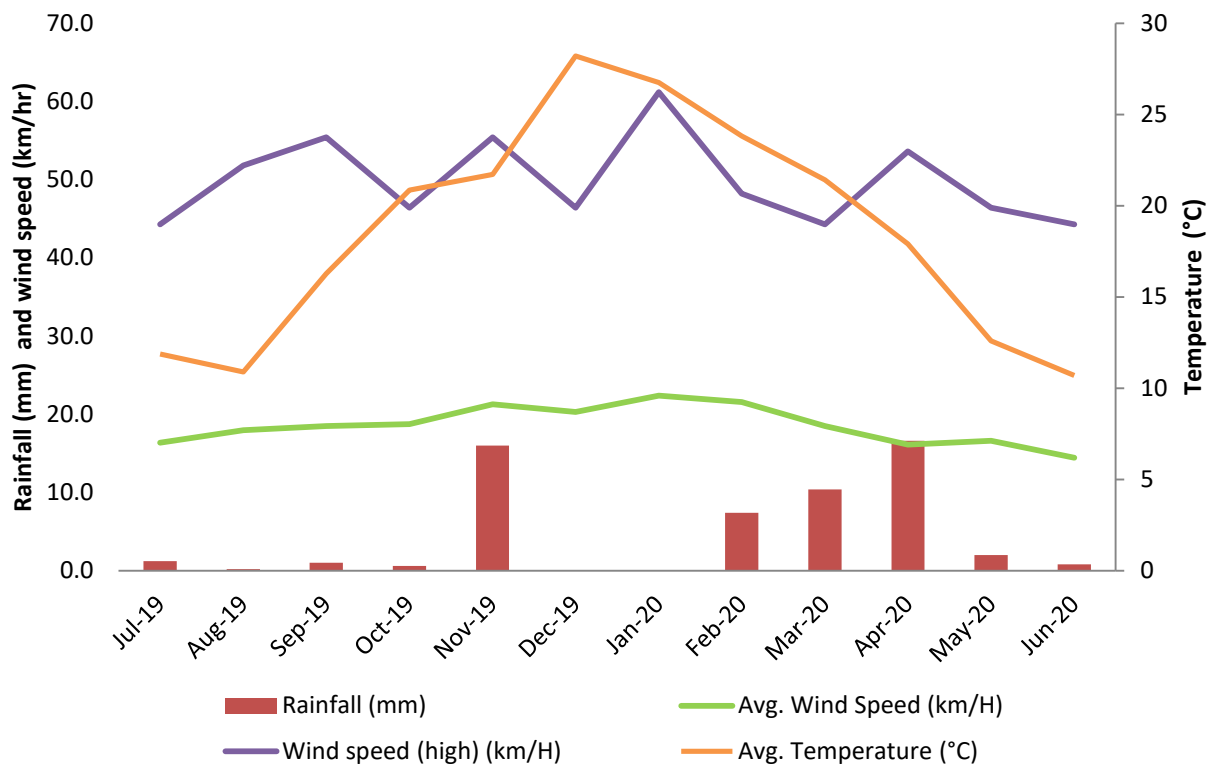
Figure 2. Average monthly temperature, wind speed and total rainfall for the 12 months up to and including June 2020.

The average temperature, average and highest wind speed as well as total rainfall for the previous 12 month period is depicted in Figure 2.
