Licensee	Perilya Broken Hill Limited (PBHL)
Address	Wentworth Rd, Broken Hill, NSW, 2880.
Reporting period	November 2018
Date report published on website

Meteorological Summary

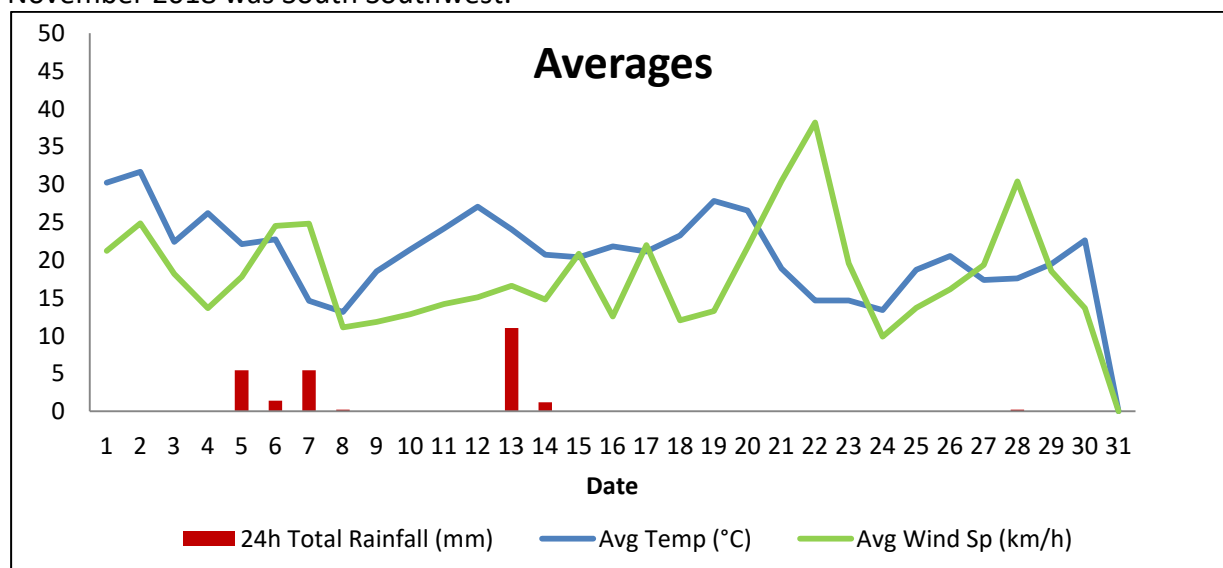
Figure 1. Average wind speed (km/hr) and daily rainfall (mm) for November 2018.

Daily average temperature and wind speed data for November 2018 is presented in graphical form in Figure 1 and provides context to the trends observed in the high volume air sampler (HVAS) and the standard dust deposition gauges (SDDG). The prevailing wind direction for November 2018 was South Southwest.

A summary of the average daily weather observations collected at Broken Hill is provided in Table 1. Total rainfall in November was 24.8 millimeters (Figure 1).

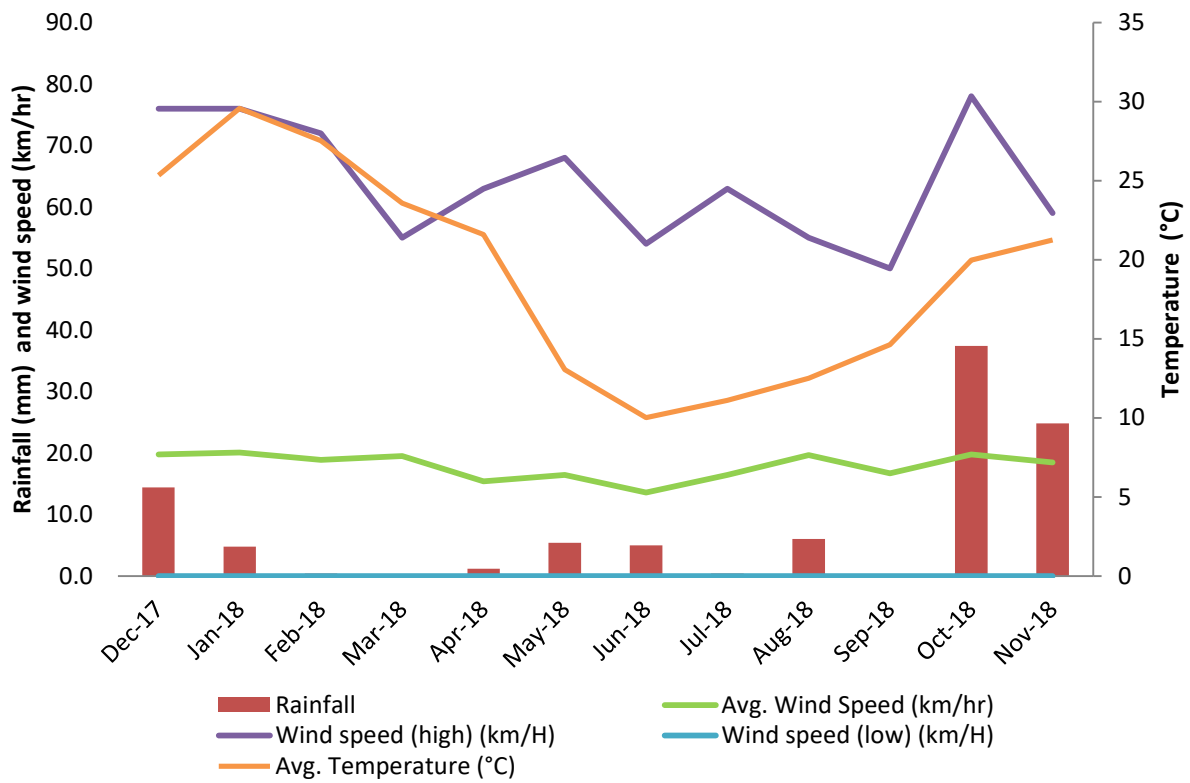
Figure 2. Average monthly temperature, wind speed and total rainfall for the 12 months up to and including November 2018.

The average temperature, average wind speed, highest and lowest wind speed and total rainfall for the previous 12 month period is depicted in Figure 2.
