Licensee	Perilya Broken Hill Limited (PBHL)
Address	Wentworth Rd, Broken Hill, NSW, 2880.
Reporting period	November 2020

## Meteorological Summary

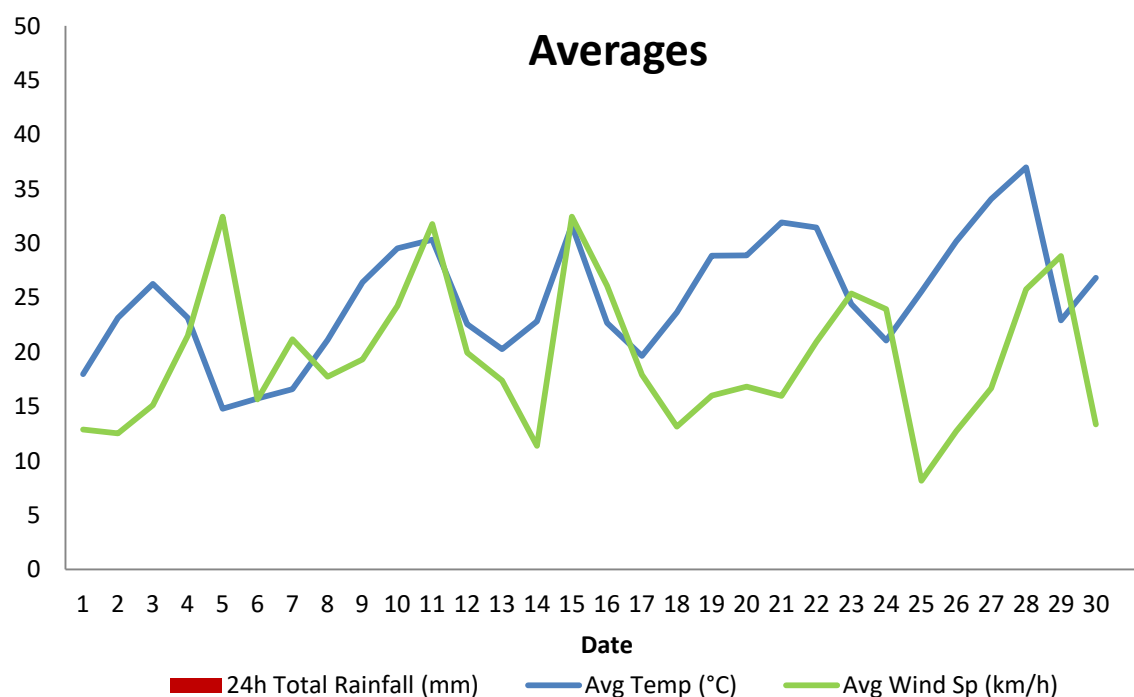
**Figure 1.** Average wind speed (km/hr) and daily rainfall (mm) for November 2020.

Daily average temperature and wind speed data for November 2020 is presented in Figure 1 and provides context to the trends observed in the high volume air sampler (HVAS) and the standard dust deposition gauges (SDDG). The prevailing wind direction for November 2020 was South.

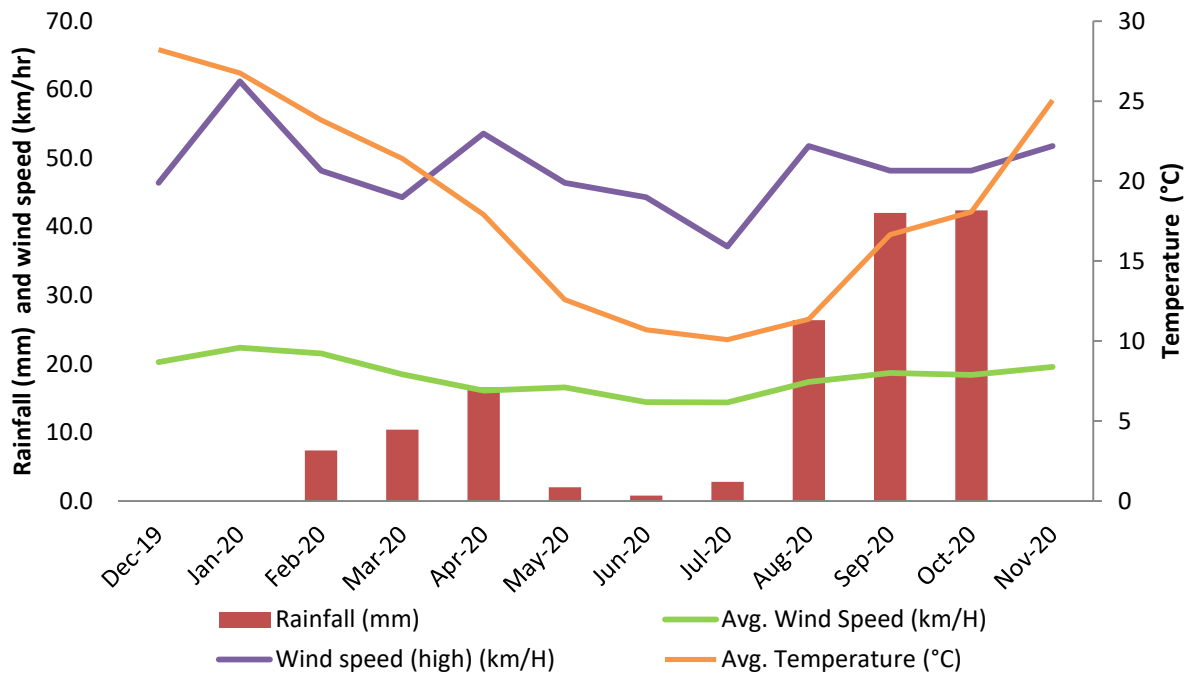
**Figure 2.** Average monthly temperature, wind speed and total rainfall for the 12 months up to and including November 2020.

The average temperature, average and highest wind speed as well as total rainfall for the previous 12 month period is depicted in Figure 2.
