Licensee	Perilya Broken Hill Limited (PBHL)
Address	Wentworth Rd, Broken Hill, NSW, 2880.
Reporting period	September 2020

Meteorological Summary

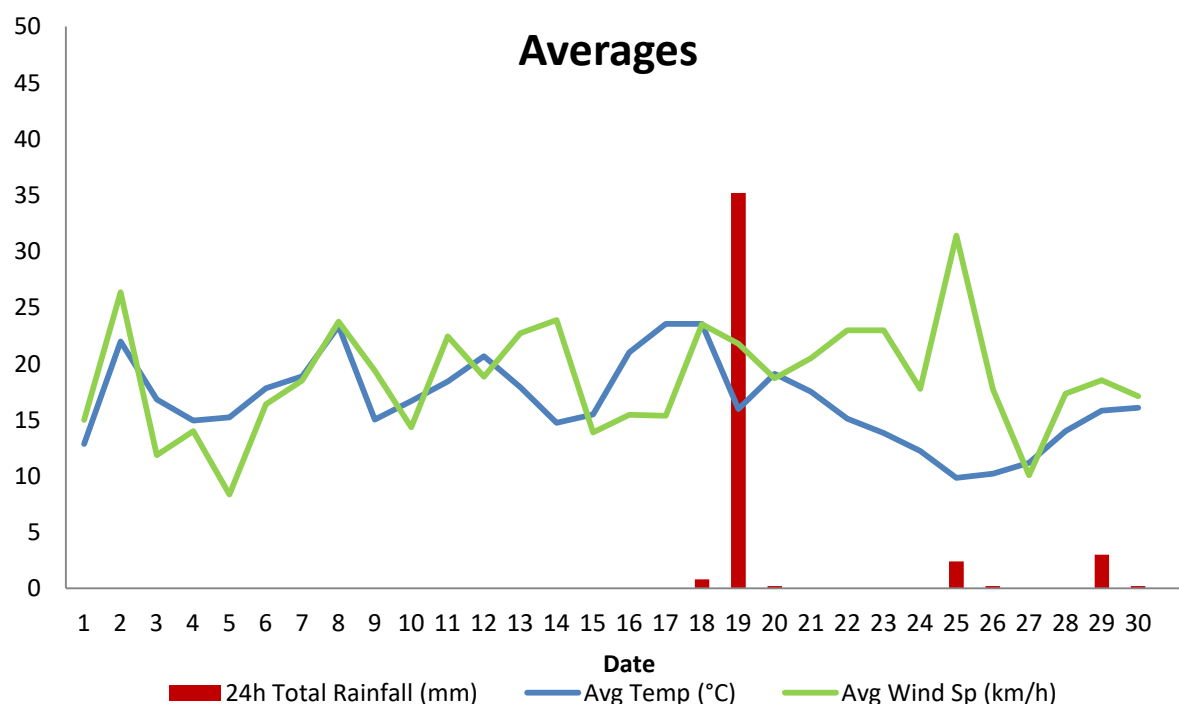
Figure 1. Average wind speed (km/hr) and daily rainfall (mm) for September 2020.

Daily average temperature and wind speed data for September 2020 is presented in Figure 1 and provides context to the trends observed in the high volume air sampler (HVAS) and the standard dust deposition gauges (SDDG). The prevailing wind direction for September 2020 was North.

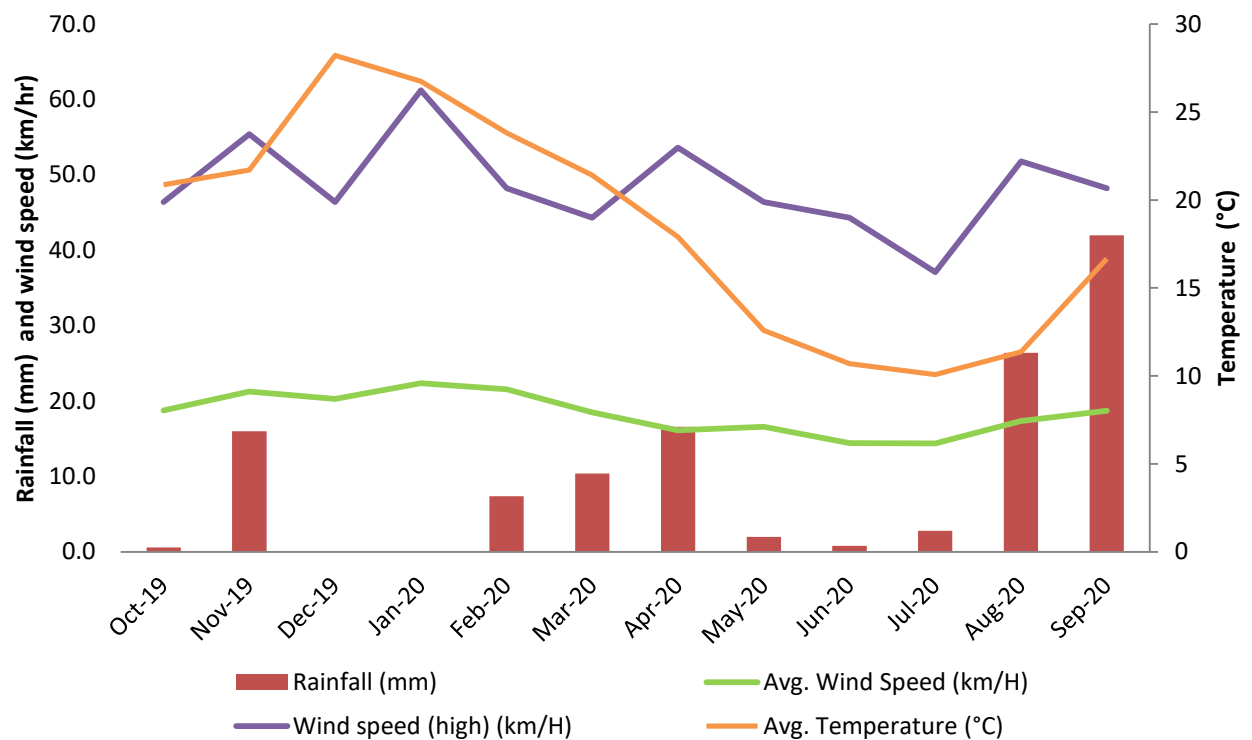
Figure 2. Average monthly temperature, wind speed and total rainfall for the 12 months up to and including September 2020.

The average temperature, average and highest wind speed as well as total rainfall for the previous 12 month period is depicted in Figure 2.
