Licensee	Perilya Broken Hill Limited (PBHL)
Address	Wentworth Rd, Broken Hill, NSW, 2880.
Reporting period	July 2018
Date report published on website

Meteorological Summary

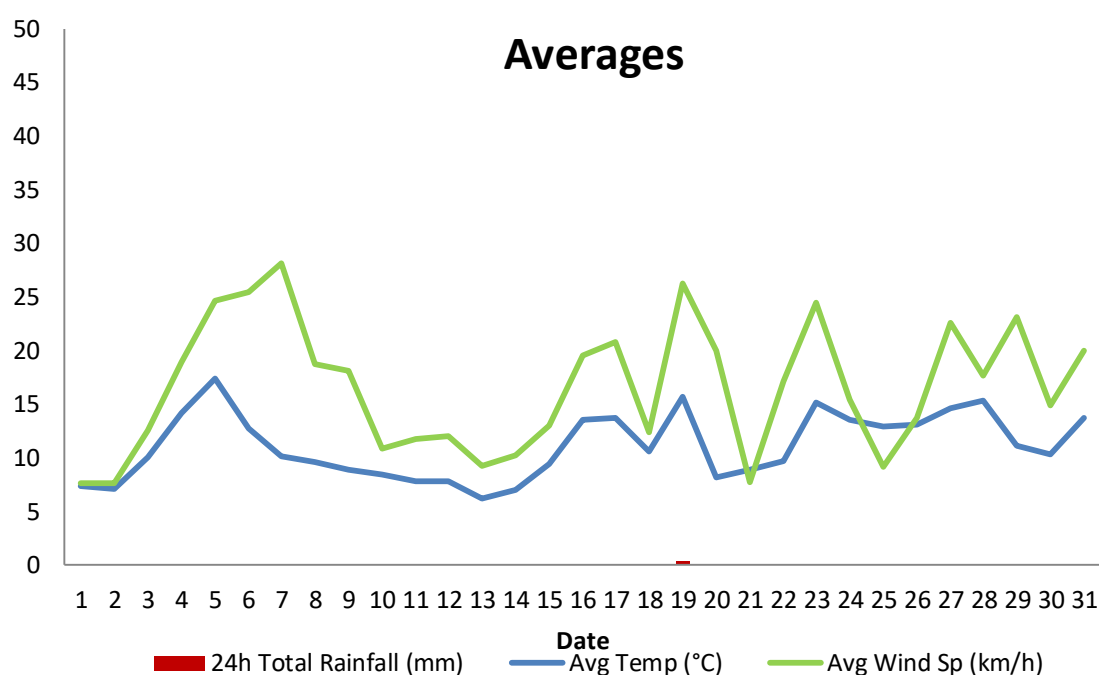
Figure 1. Average wind speed (km/hr) and daily rainfall (mm) for July 2018.

A summary of the average daily weather observations collected at Broken Hill is provided in Table 1. Total rainfall in July was 0.40 millimeters (Figure 1).

Daily average temperature and wind speed data for July 2018 is presented in graphical form in Figure 1 and provides context to the trends observed in the high volume air sampler (HVAS) and the standard dust deposition gauges (SDDG). The prevailing wind direction for July 2018 was North.

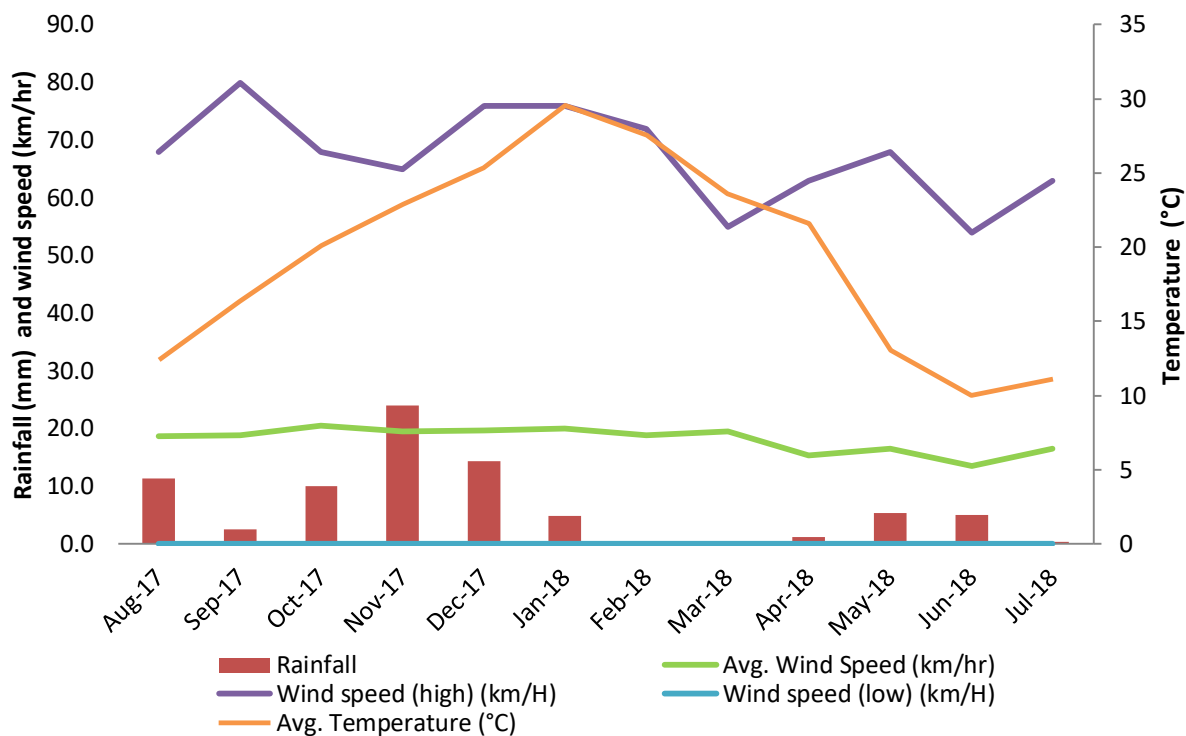
Figure 2. Average monthly temperature, wind speed and total rainfall for the 12 months up to and including July 2018.

The average temperature, average wind speed, highest and lowest wind speed and total rainfall for the previous 12 month period is depicted in Figure 2.
