Licensee	Perilya Broken Hill Limited (PBHL)
Address	Wentworth Rd, Broken Hill, NSW, 2880.
Reporting period	June 2015
Date report published on website

Meteorological Summary

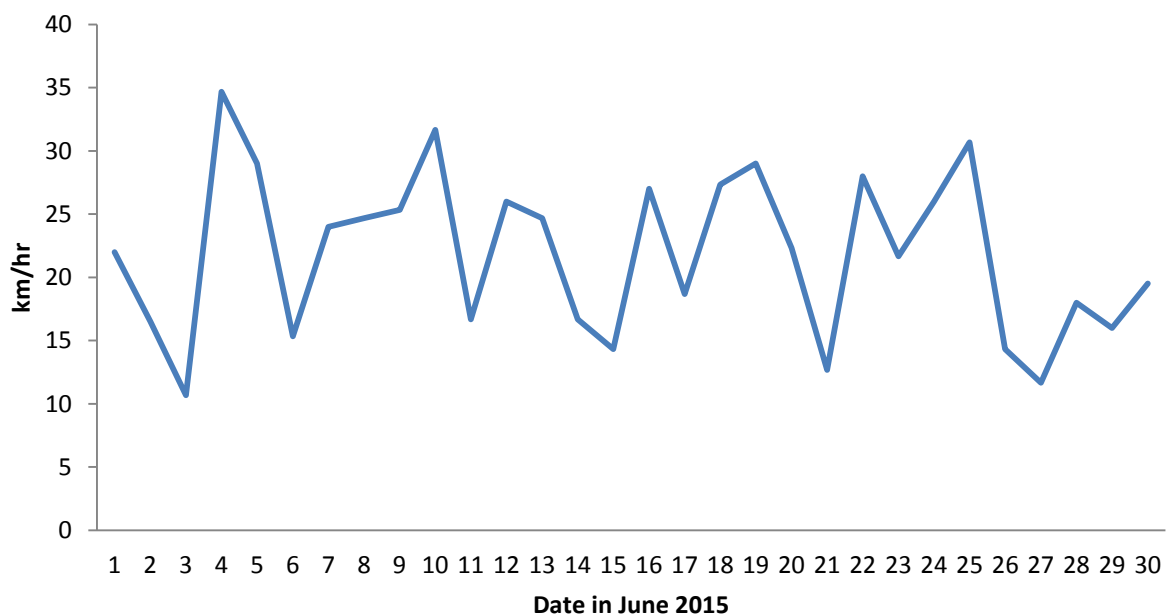
Figure 1. Average wind speed (km/hr) on a daily basis for June 2015.

Daily average wind speed data for June 2015 is presented in graphical form in Figure 1 and provides context to the trends observed in the high volume air sampler (HVAS) and the standard dust deposition gauges (SDDG). The prevailing wind directions for June 2015 were south, south-west and west, south-west.

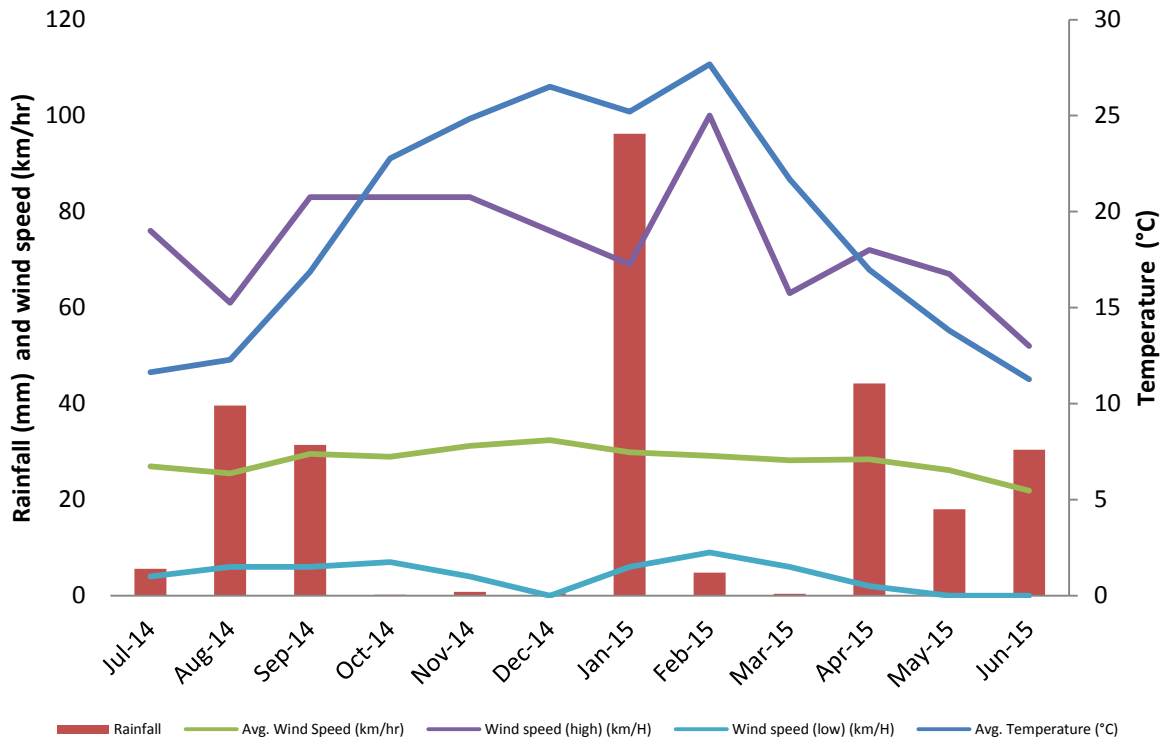
Figure 2. Average monthly temperature, wind speed and total rainfall for the 12 months up to and including June 2015.

The average temperature, average wind speed, highest and lowest wind speed and total rainfall for the previous 12 month period is depicted in Figure 2.
