Licensee	Perilya Broken Hill Limited (PBHL)
Address	Wentworth Rd, Broken Hill, NSW, 2880.
Reporting period	May 2018
Date report published on website

Meteorological Summary

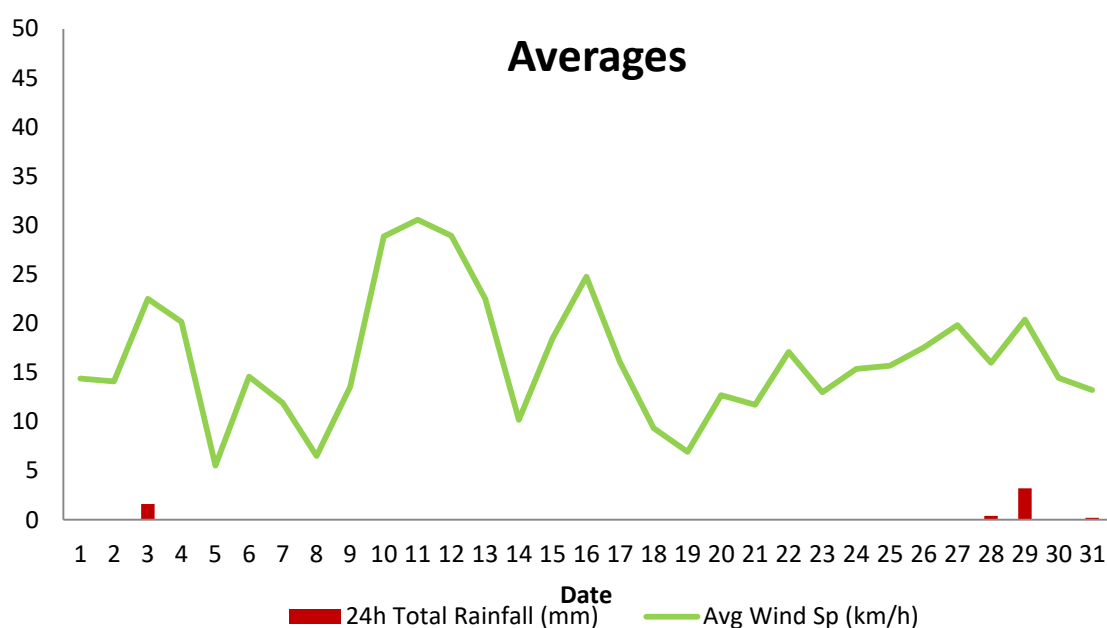
Figure 1. Average wind speed (km/hr) and daily rainfall (mm) for May 2018.

A summary of the average daily weather observations collected at Broken Hill is provided in Table 1. Total rainfall in May was 5.40 millimeters (Figure 1).

Daily average temperature and wind speed data for May 2018 is presented in graphical form in Figure 1 and provides context to the trends observed in the high volume air sampler (HVAS) and the standard dust deposition gauges (SDDG). The prevailing wind direction for May 2018 was south.

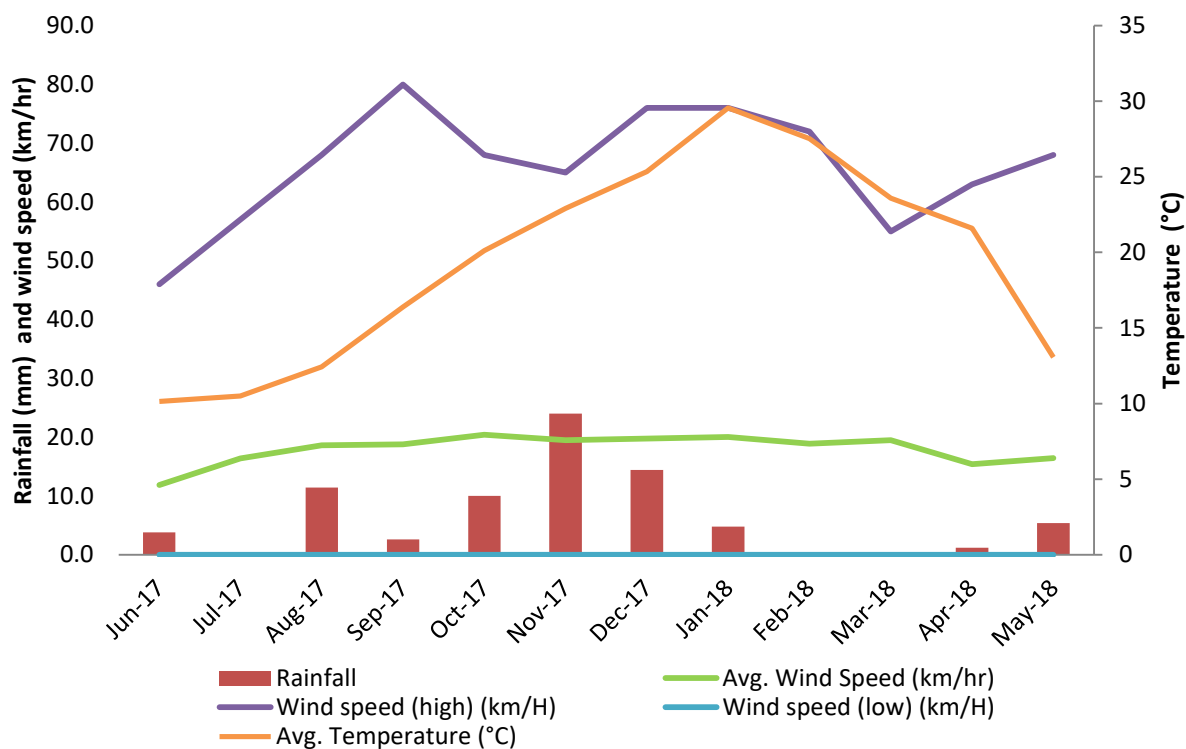
Figure 2. Average monthly temperature, wind speed and total rainfall for the 12 months up to and including May 2018.

The average temperature, average wind speed, highest and lowest wind speed and total rainfall for the previous 12 month period is depicted in Figure 2.
