Licensee	Perilya Broken Hill Limited (PBHL)
Address	Wentworth Rd, Broken Hill, NSW, 2880.
Reporting period	November 2014
Date report published on website

Meteorological Summary

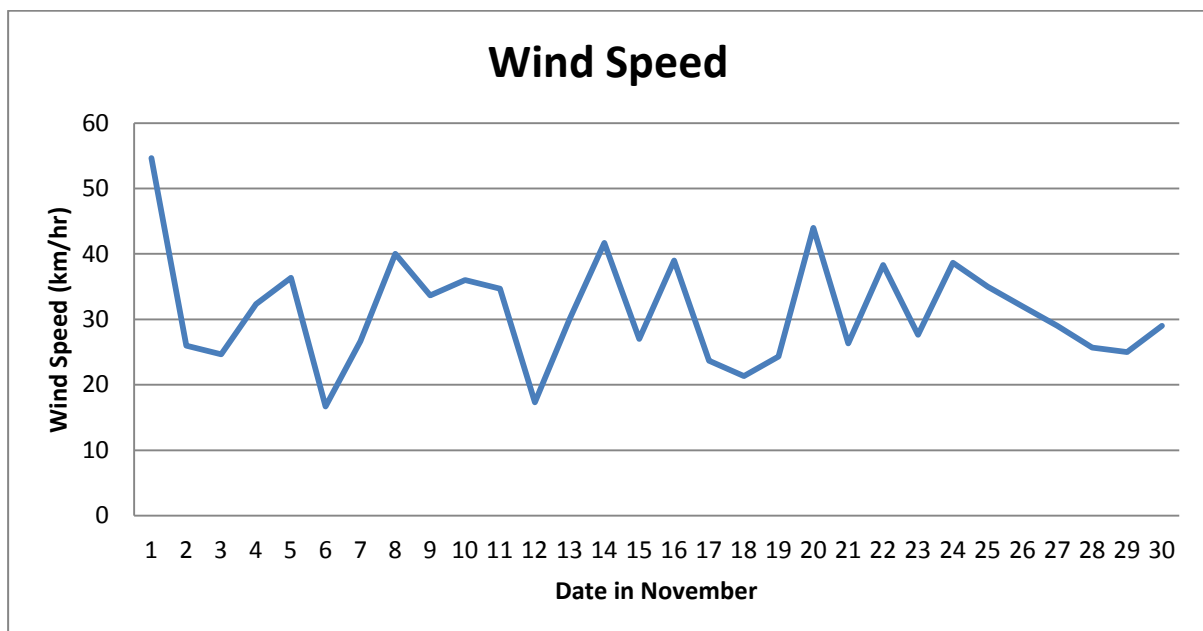
Daily average wind speed data for November is presented in graphical form in Figure 1 and provides context to the trends observed in the high volume air sampler (HVAS) and the standard dust deposition gauges (SDDG). The prevailing wind direction for November was south, south-west.

Figure 1. Average wind speed (km/hr) on a daily basis for November 2014.

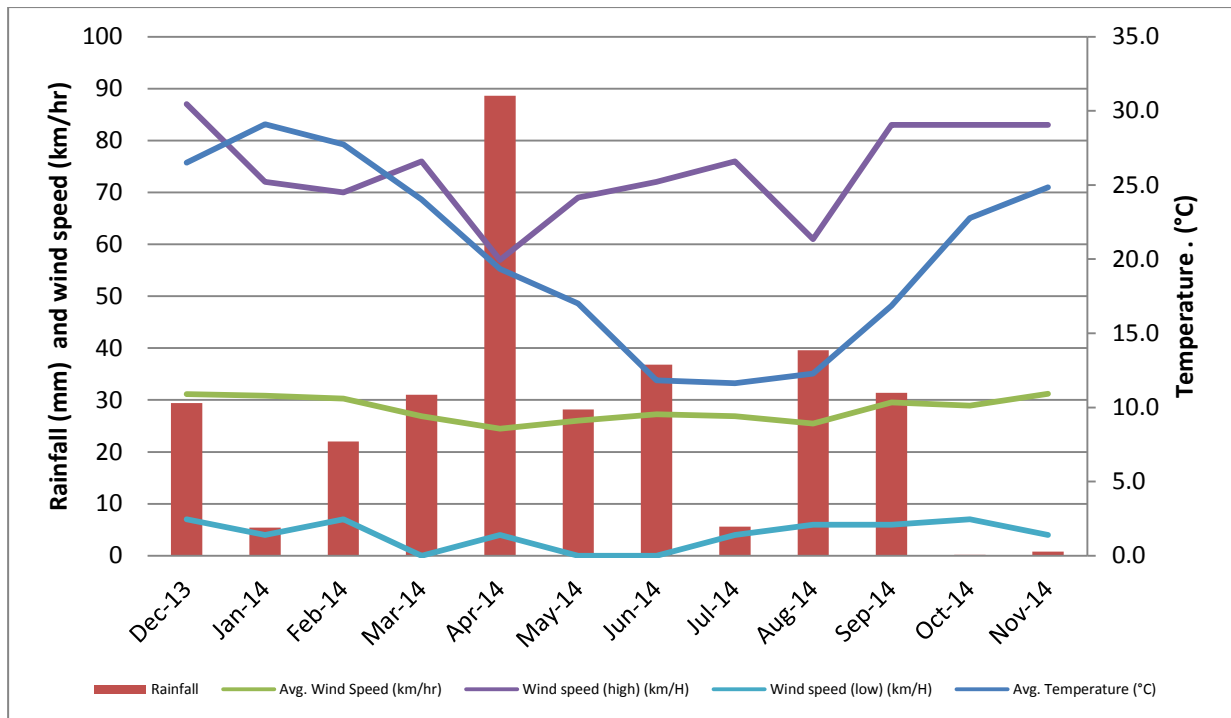
The average temperature, average wind speed, highest and lowest wind speed and total rainfall for the previous 12 month period is depicted in Figure 2.

Figure 2. Average monthly temperature, wind speed and total rainfall for the 12 months up to and including November 2014.
