Licensee	Perilya Broken Hill Limited (PBHL)
Address	Wentworth Rd, Broken Hill, NSW, 2880.
Reporting period	September 2015
Date report published on website

Meteorological Summary

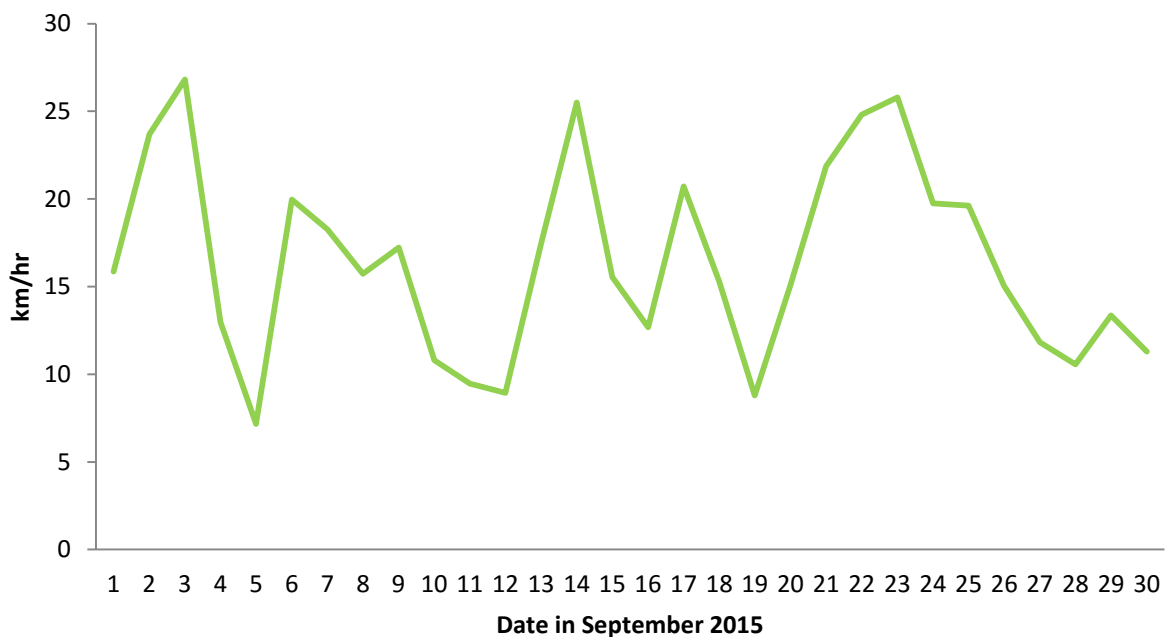
Daily average wind speed data for September 2015 is presented in graphical form in Figure 1 and provides context to the trends observed in the high volume air sampler (HVAS) and the standard dust deposition gauges (SDDG). The prevailing wind direction for September 2015 was south south-east.

Figure 1. Average wind speed (km/hr) on a daily basis for September 2015.

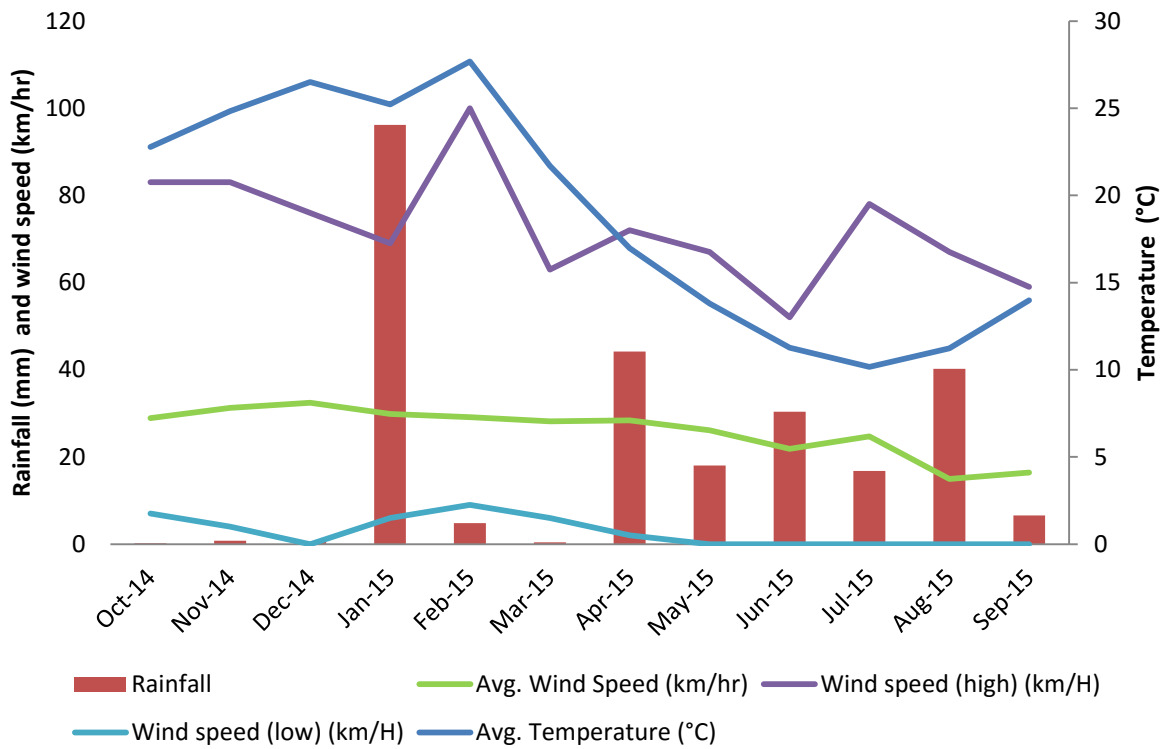
The average temperature, average wind speed, highest and lowest wind speed and total rainfall for the previous 12 month period is depicted in Figure 2.

Figure 2. Average monthly temperature, wind speed and total rainfall for the 12 months up to and including September 2015.
