Licensee	Perilya Broken Hill Limited (PBHL)
Address	Wentworth Rd, Broken Hill, NSW, 2880.
Environmental Protection Licence	2688 (Southern Operations)
Link to Environmental Protection Licence	<a href="http://www.epa.nsw.gov.au/prpoeoapp/ViewPOEOLicence.aspx?DOCID=31560&amp;SYSUID=1&amp;LICID=2688">http://www.epa.nsw.gov.au/prpoeoapp/ViewPOEOLicence.aspx?DOCID=31560&amp;SYSUID=1&amp;LICID=2688</a>
Reporting period	June 2017
Date report published on website

## Environmental Protection Licence 2688

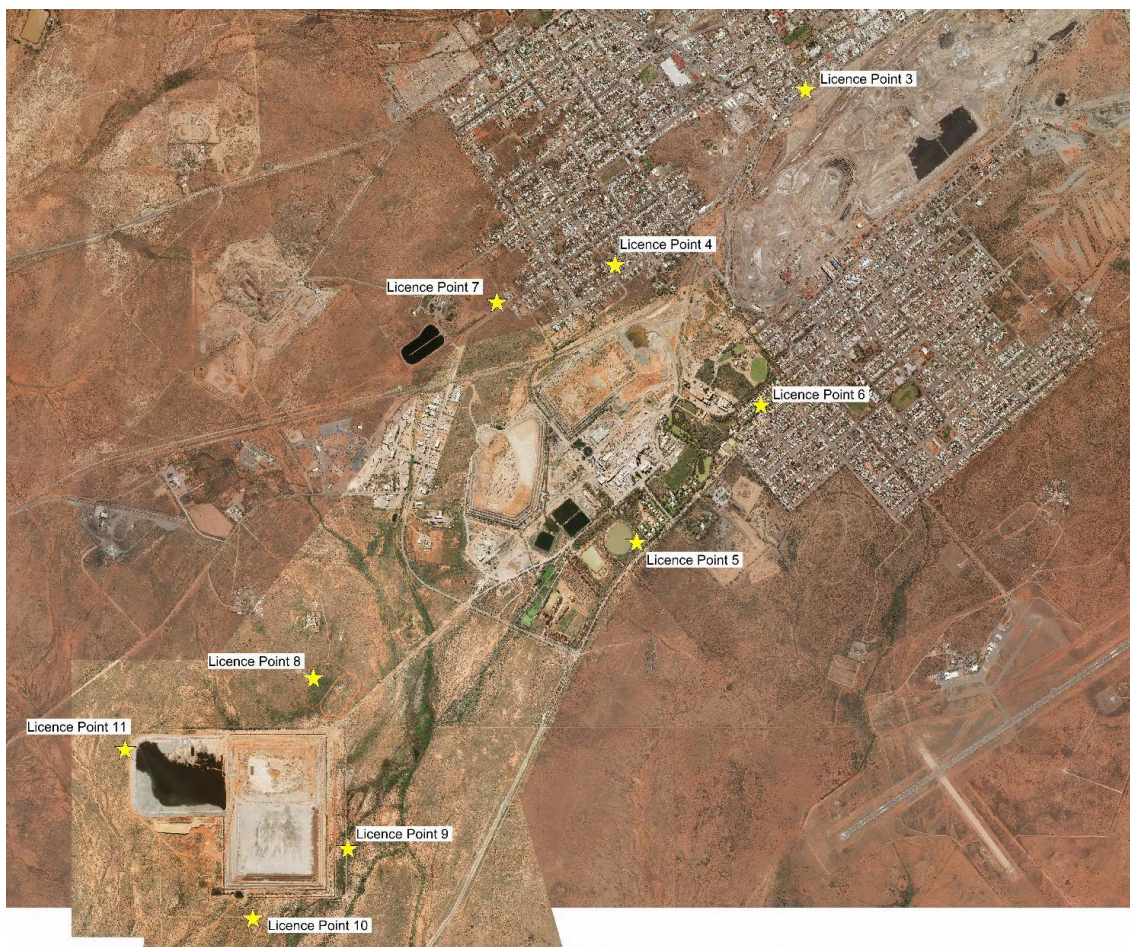
**Figure 1.** Location of the EPL 2688 deposition dust gauges associated with Perilya's Southern Operations.

Perilya Broken Hill Limited (PBHL) has nine (9) deposition dust gauge stations located at strategic points around the Southern Operations site (Figure 1). A summary of Environmental Protection Licence (EPL) 2688 conditions is shown in Table 1.

<b>Licence Point</b>	<b>Particulates – deposited matter (g/m<sup>2</sup>/month)</b>	<b>Total Lead (g/m<sup>2</sup>/month)</b>
3	1.8	0.006
4	<0.1	0.028
5	<0.1	0.029
6	<0.1	0.005
7	<0.1	0.012
8	<0.1	0.015
9	<0.1	0.01
10	<0.1	0.007
11	<0.1	0.008

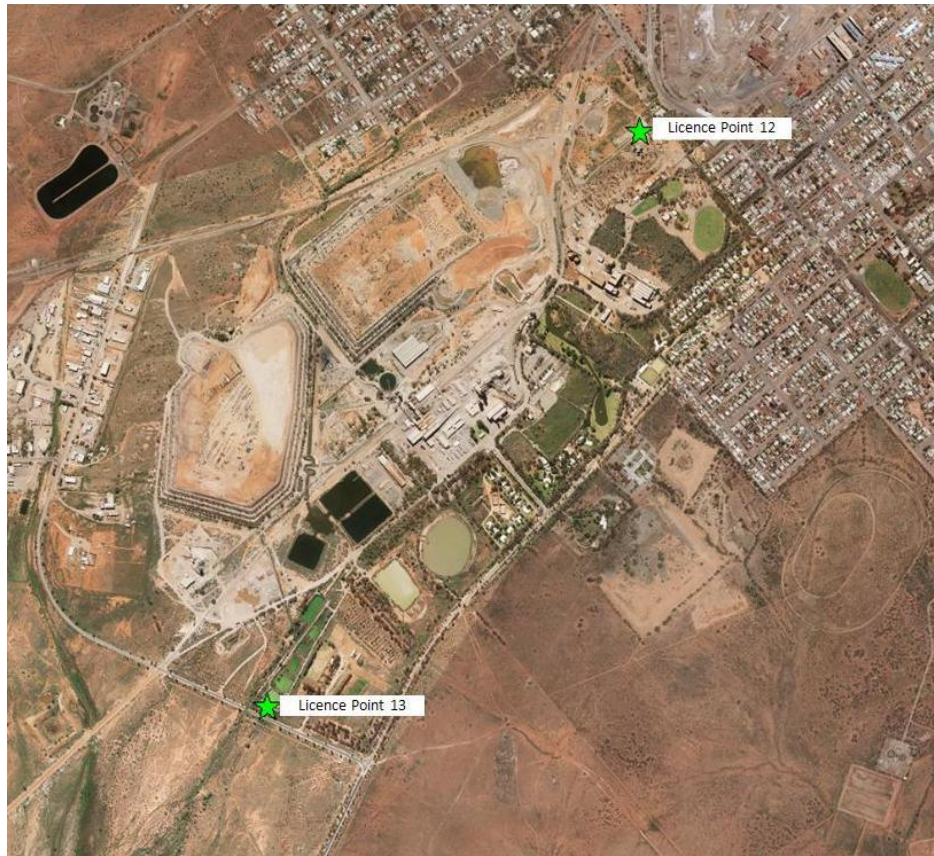
**Figure 2.** Location of the HVAS associated with EPL 2688.

PBHL currently operates two (2) high volume air samplers (HVAS) in relation to EPL 2688, both located at the Southern Operations site (Figure 2). HVAS sampling stations operate (sample) routinely for a 24-hour period every six (6) days on a regular basis.

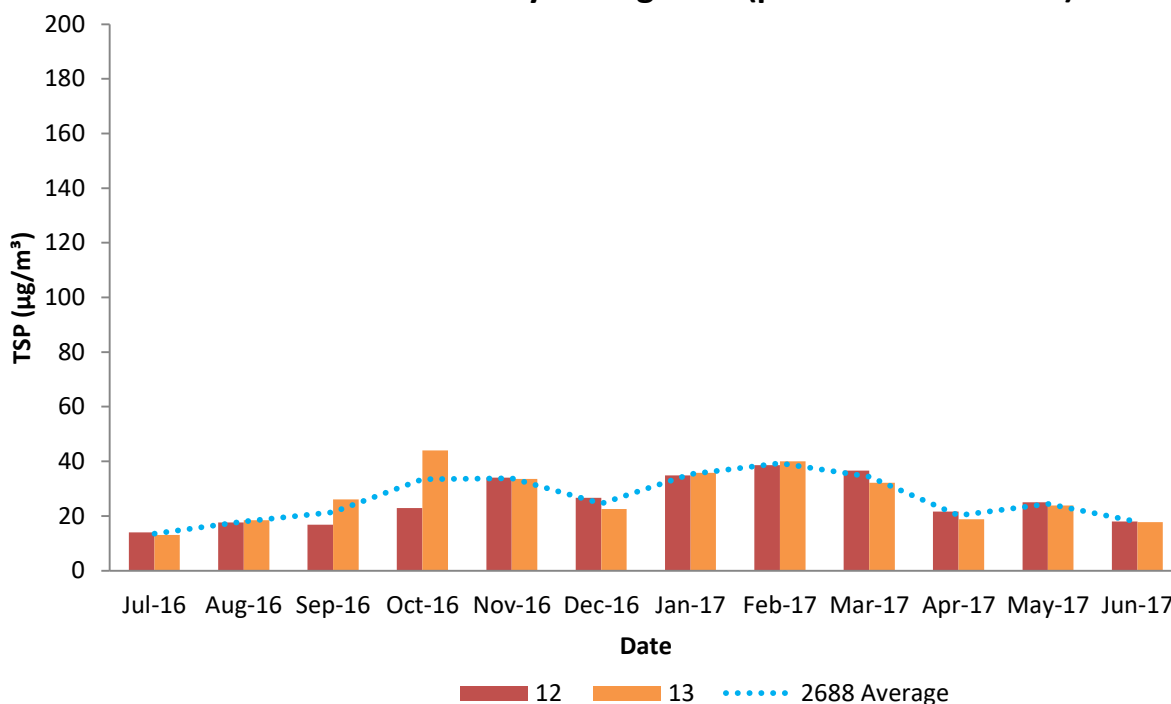
**Figure 3.** Average TSP results for the 12 months up to and including June.

Total suspended particulate (TSP) and total lead results are presented in Table 4. Monthly averages for TSP and total lead for the previous 12 months are shown in Figure 3 and Figure 4 respectively. The results for the HVAS monitoring were received on the 03-07-2017, 18-07-2017 and 21-07-2017.

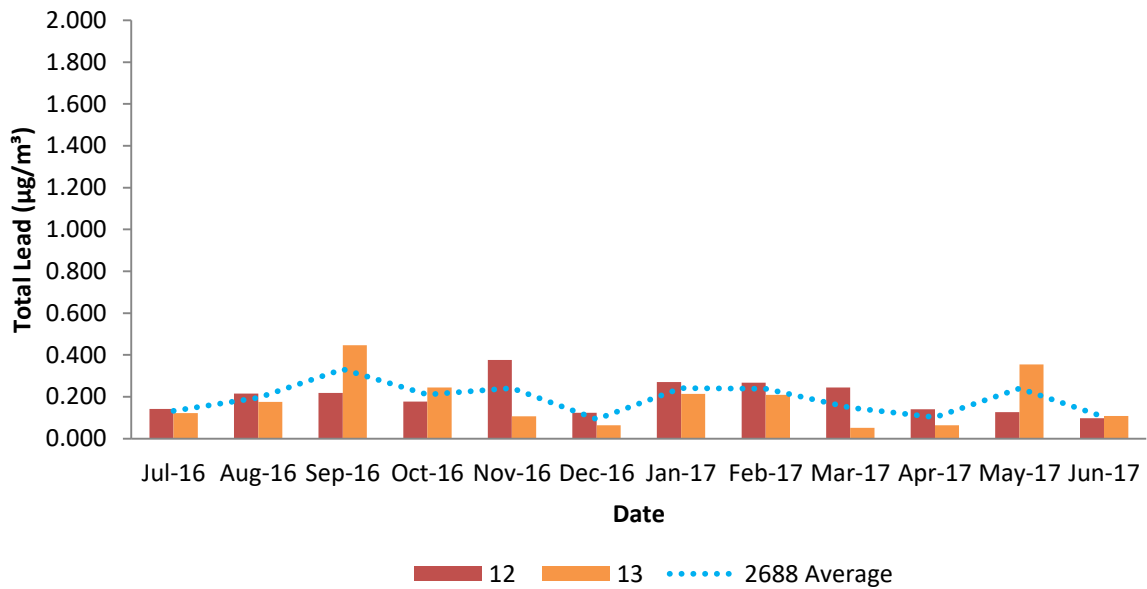
**Figure 4.** Average total lead results for the 12 months up to and including June.

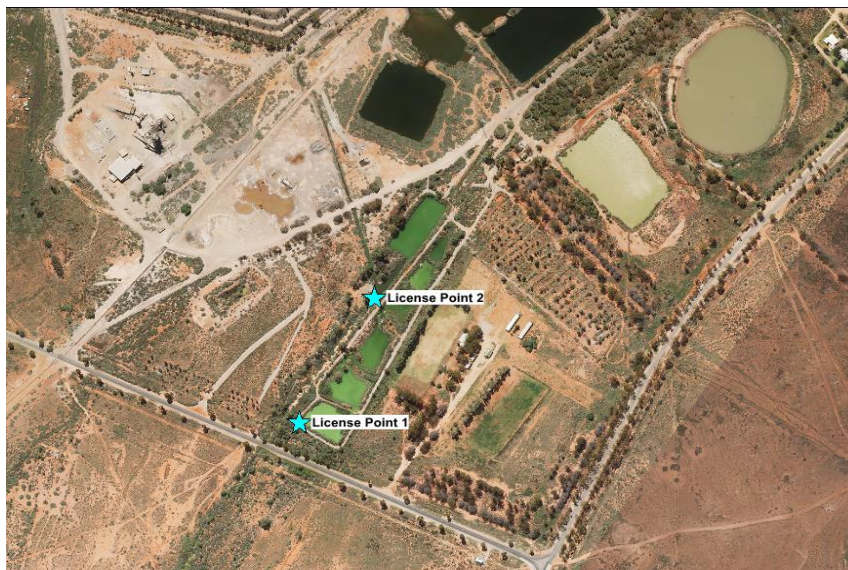
**Figure 5.** Location of the EPL2688 licenced discharge points.

PBHL has two (2) licenced discharge points for surface waters, Licence Point 1 and Licence Point 2 (Figure 5). A summary of the licence conditions relating to discharges of waters from these two points is shown in Table 5.

Licence Points 1 and 2 did not discharge during June. No discharge has occurred for the reporting period.

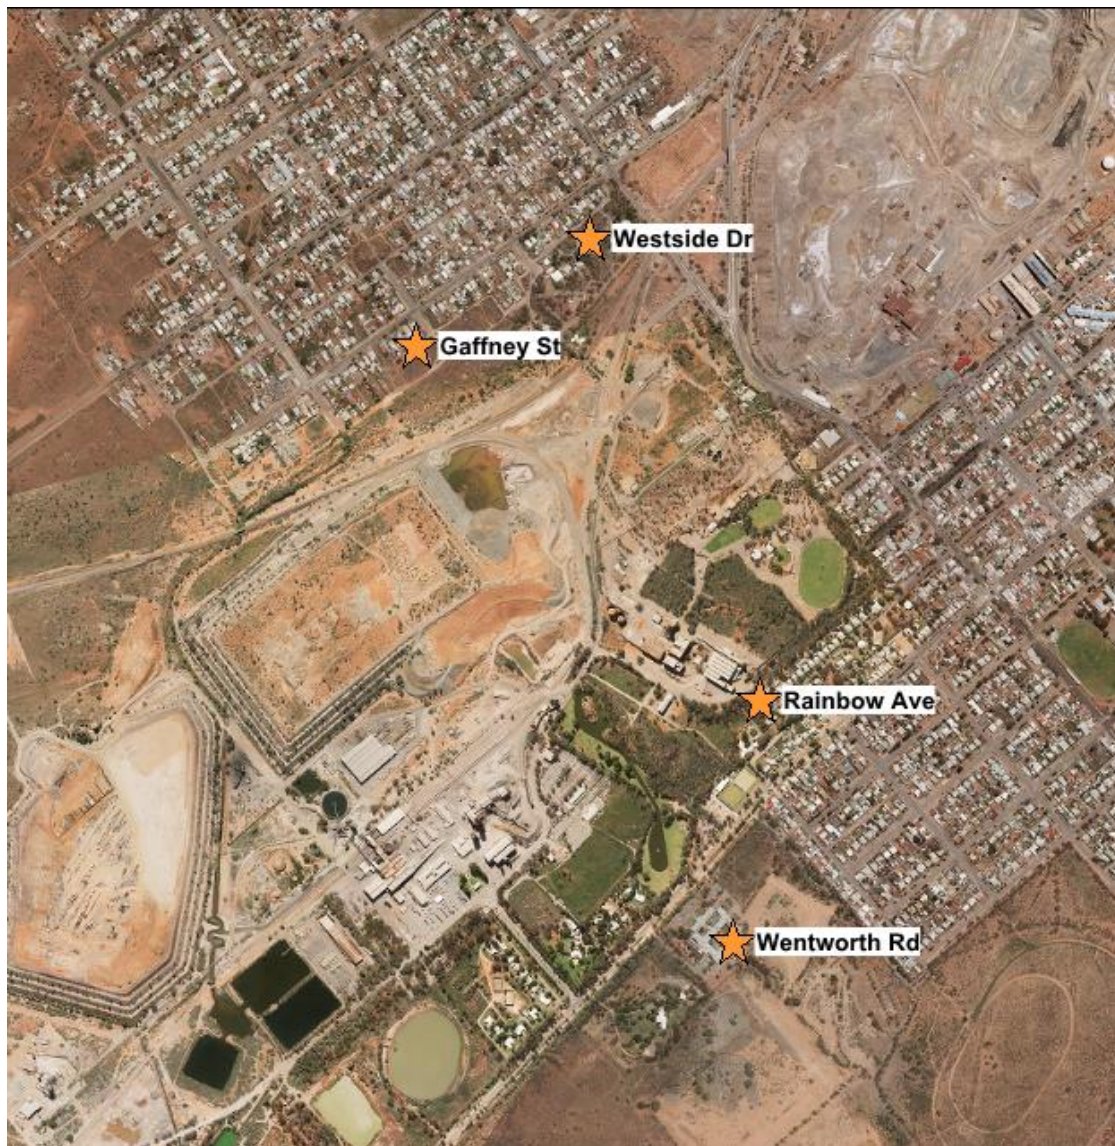
**Figure 6.** Location of EPL2688 blast monitors.

PBHL has four (4) blast monitors associated with the Southern Operations (Figure 6). A summary of EPL 2688 conditions for blasting is provided in Table 7.

A total of 28 production blasts were conducted during June (Table 8). All blasts were within licence conditions.
