Licensee	Perilya Broken Hill Limited (PBHL)
Address	Wentworth Rd, Broken Hill, NSW, 2880.
Reporting period	December 2019

Meteorological Summary

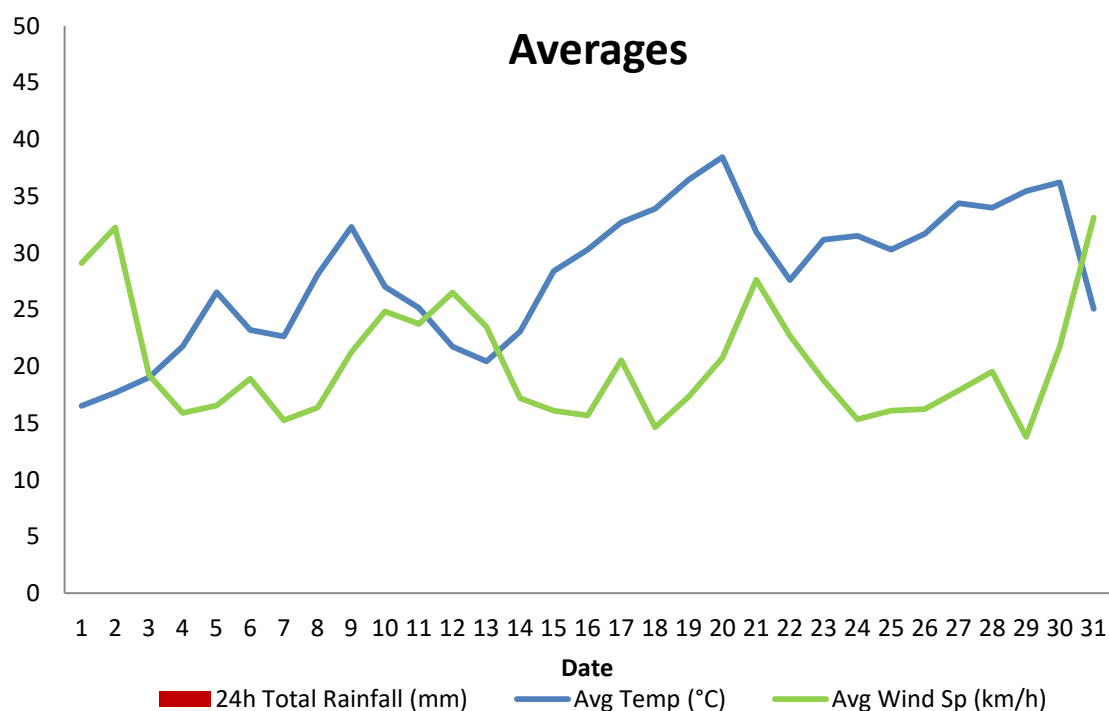
Daily average temperature and wind speed data for December 2019 is presented in Figure 1 and provides context to the trends observed in the high volume air sampler (HVAS) and the standard dust deposition gauges (SDDG). The prevailing wind direction for December 2019 was South.

Figure 1. Average wind speed (km/hr) and daily rainfall (mm) for December 2019.

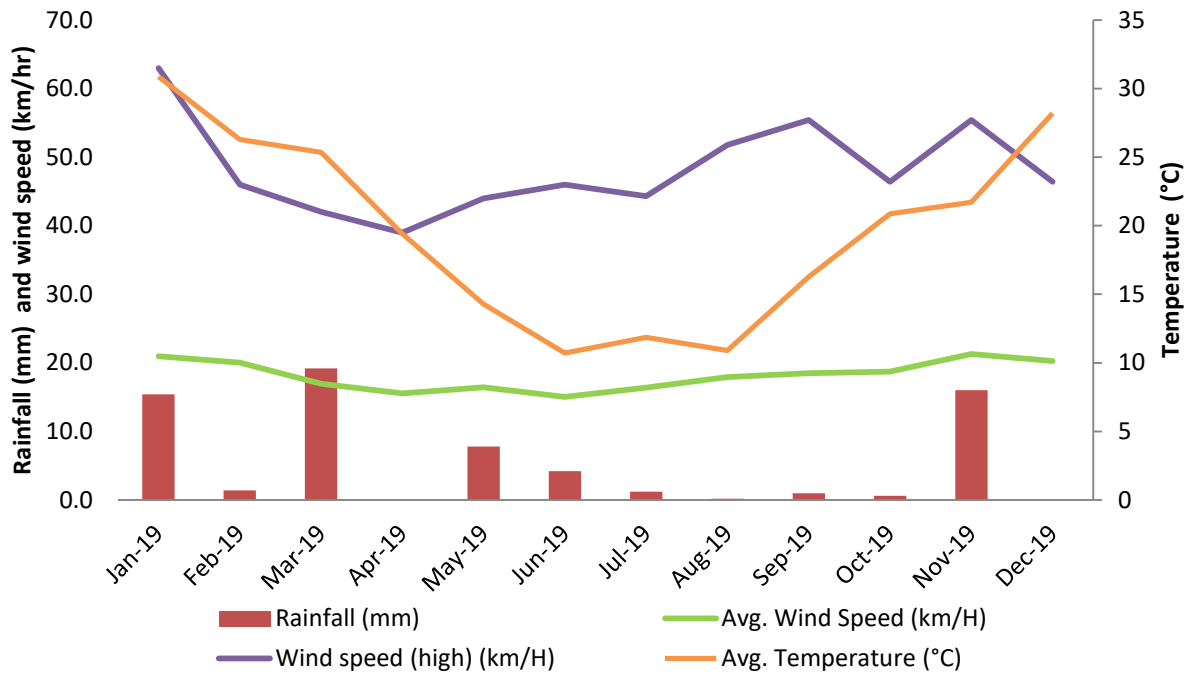
The average temperature, average and highest wind speed as well as total rainfall for the previous 12 month period is depicted in Figure 2.

Figure 2. Average monthly temperature, wind speed and total rainfall for the 12 months up to and including December 2019.
