Licensee	Perilya Broken Hill Limited (PBHL)
Address	Wentworth Rd, Broken Hill, NSW, 2880.
Reporting period	July 2019

Meteorological Summary

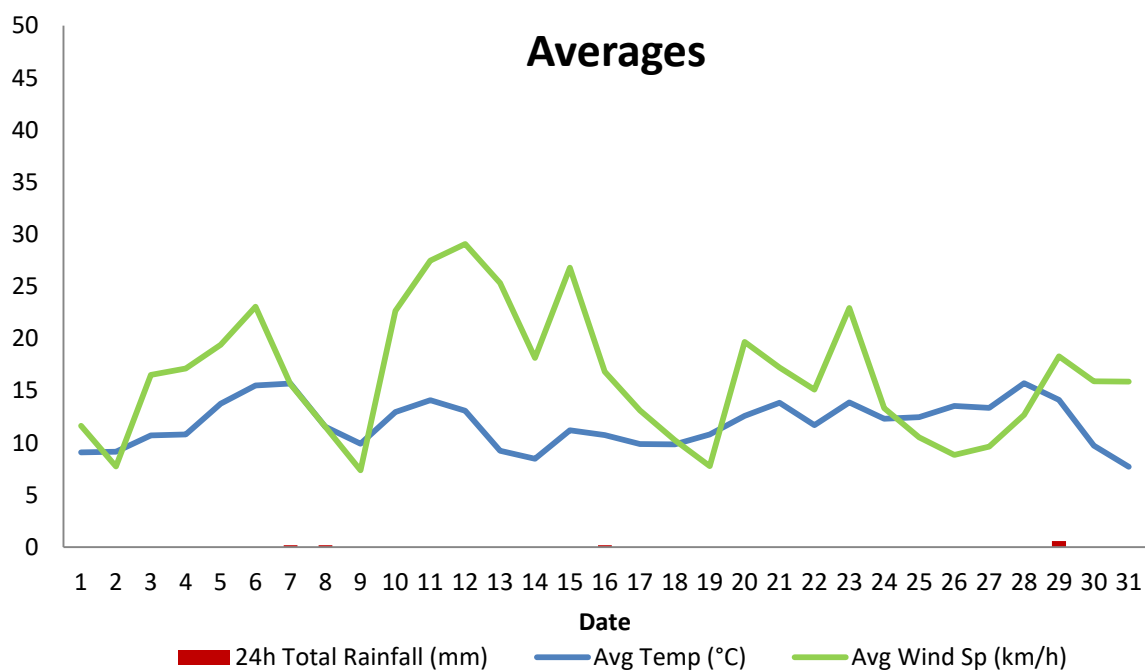
Figure 1. Average wind speed (km/hr) and daily rainfall (mm) for July 2019.

Daily average temperature and wind speed data for July 2019 is presented in Figure 1 and provides context to the trends observed in the high volume air sampler (HVAS) and the standard dust deposition gauges (SDDG). The prevailing wind direction for July 2019 was North.

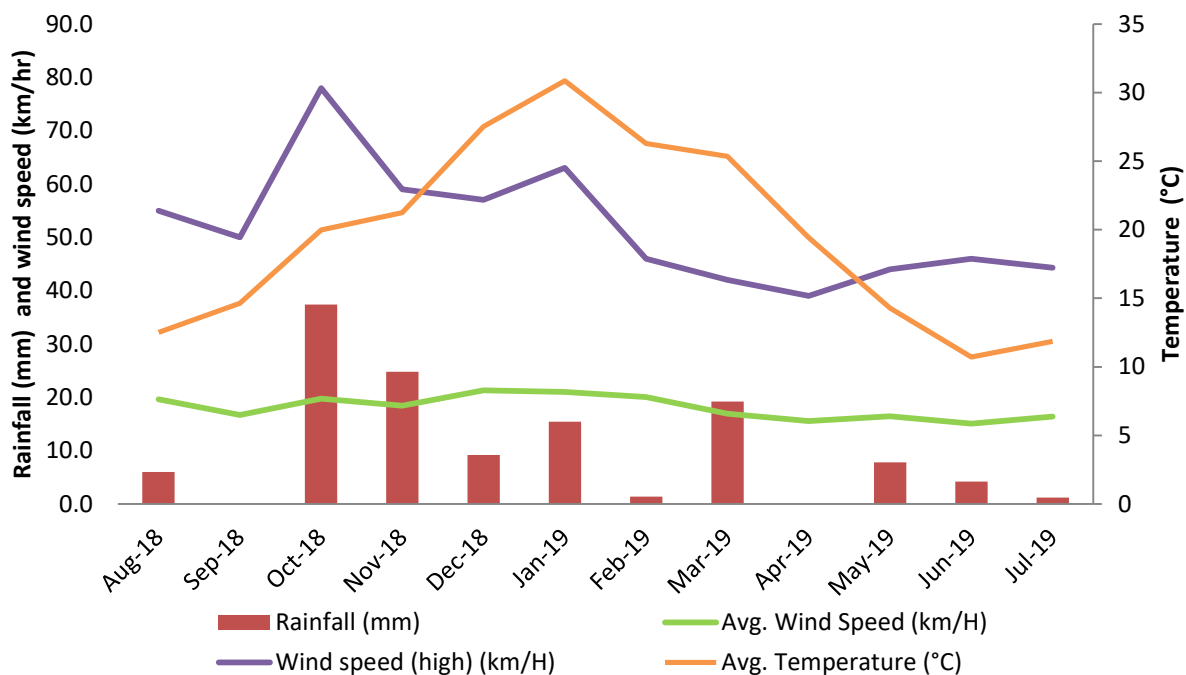
Figure 2. Average monthly temperature, wind speed and total rainfall for the 12 months up to and including July 2019.

The average temperature, average and highest wind speed as well as total rainfall for the previous 12 month period is depicted in Figure 2.
