Licensee	Perilya Broken Hill Limited (PBHL)
Address	Wentworth Rd, Broken Hill, NSW, 2880.
Reporting period	October 2019

Meteorological Summary

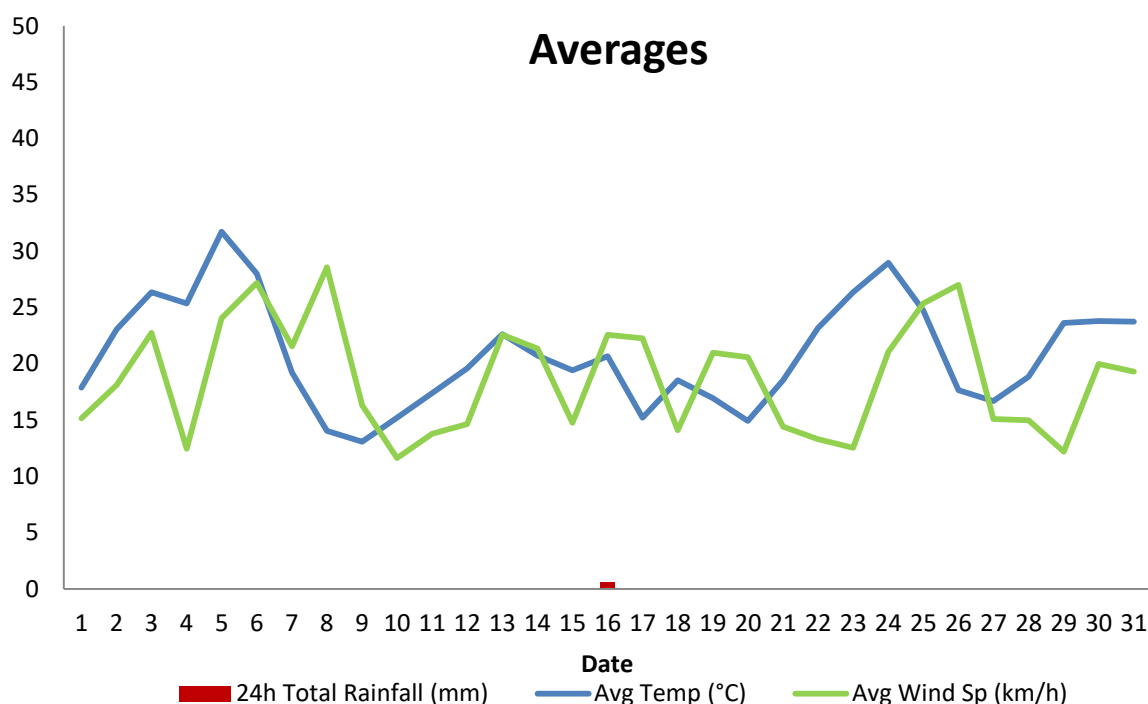
Figure 1. Average wind speed (km/hr) and daily rainfall (mm) for October 2019.

Daily average temperature and wind speed data for October 2019 is presented in Figure 1 and provides context to the trends observed in the high volume air sampler (HVAS) and the standard dust deposition gauges (SDDG). The prevailing wind direction for October 2019 was South- Southwest.

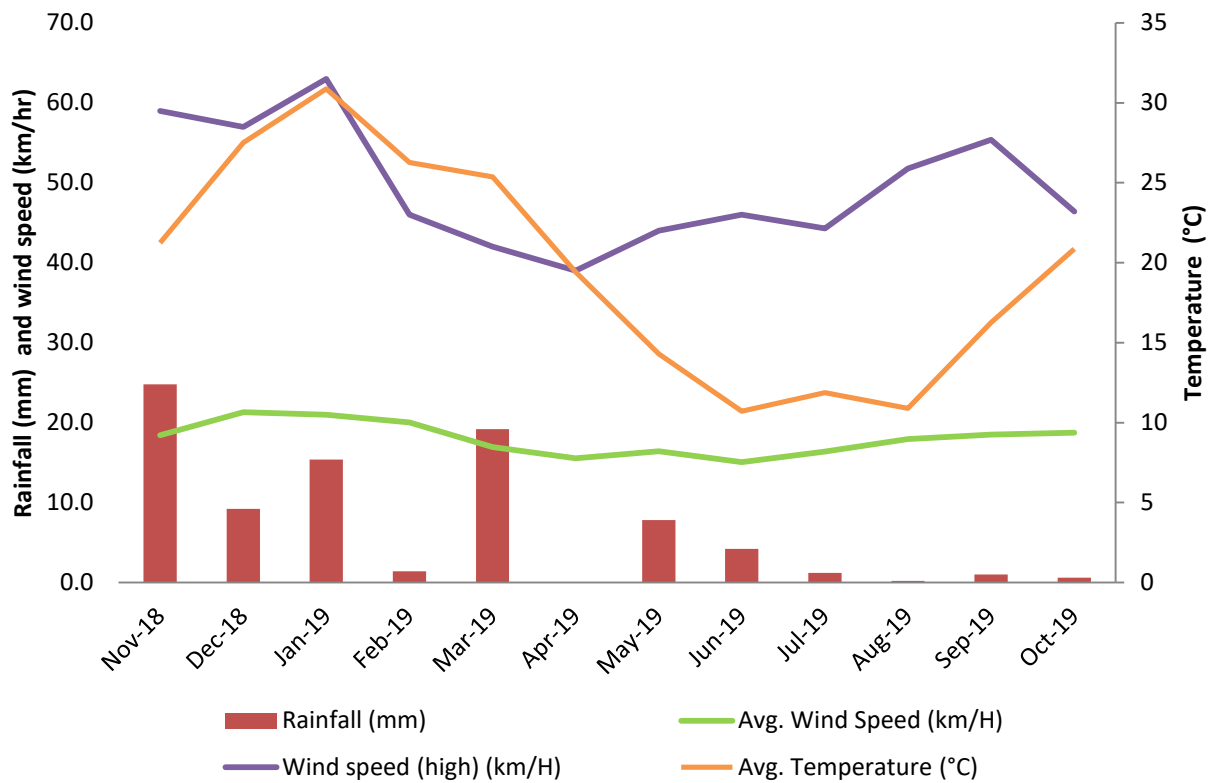
Figure 2. Average monthly temperature, wind speed and total rainfall for the 12 months up to and including October 2019.

The average temperature, average and highest wind speed as well as total rainfall for the previous 12 month period is depicted in Figure 2.
