Licensee	Perilya Broken Hill Limited (PBHL)
Address	Wentworth Rd, Broken Hill, NSW, 2880.
Reporting period	September 2019

Meteorological Summary

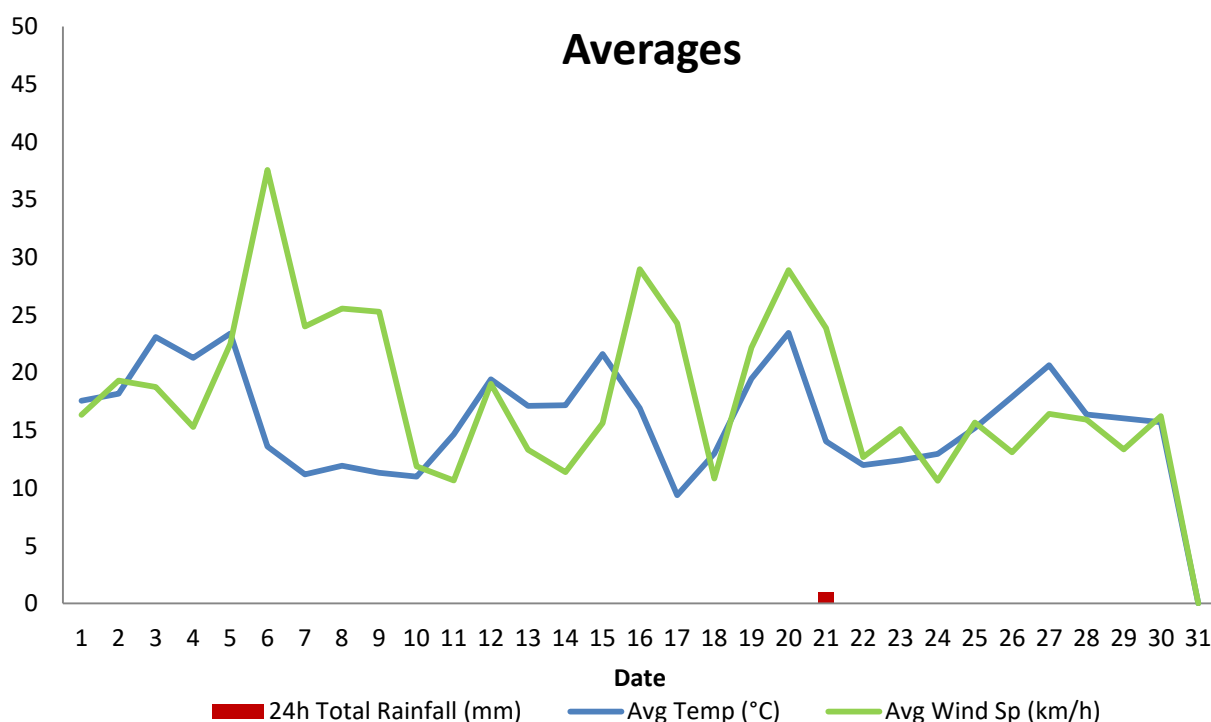
Figure 1. Average wind speed (km/hr) and daily rainfall (mm) for September 2019.

Daily average temperature and wind speed data for September 2019 is presented in Figure 1 and provides context to the trends observed in the high volume air sampler (HVAS) and the standard dust deposition gauges (SDDG). The prevailing wind direction for September 2019 was South.

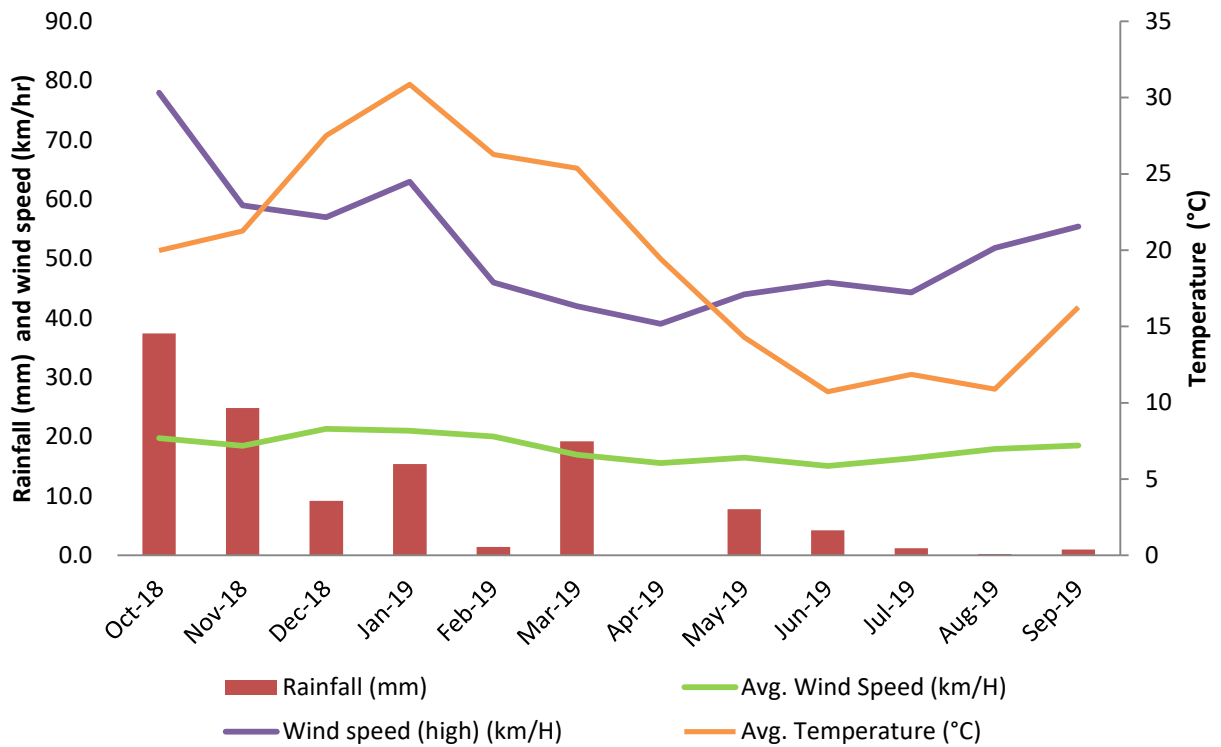
Figure 2. Average monthly temperature, wind speed and total rainfall for the 12 months up to and including September 2019.

The average temperature, average and highest wind speed as well as total rainfall for the previous 12 month period is depicted in Figure 2.
