Licensee	Perilya Broken Hill Limited (PBHL)
Address	Wentworth Rd, Broken Hill, NSW, 2880.
Reporting period	July 2017
Date report published on website

Meteorological Summary

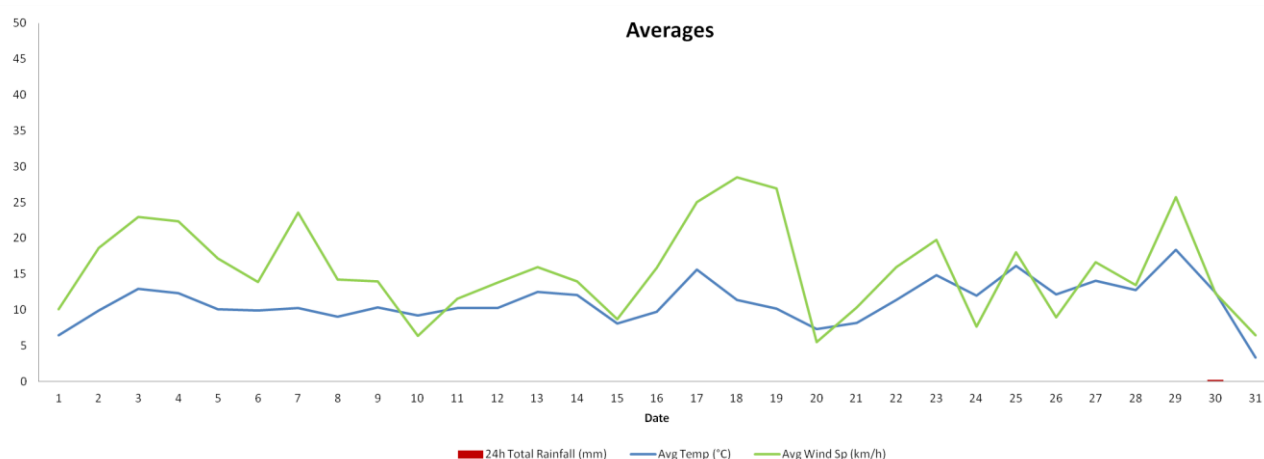
Figure 1. Average wind speed (km/hr) and daily rainfall (mm) for July 2017.

A summary of the average daily weather observations collected at Broken Hill is provided in Table 1. Total rainfall in July was 0.20 millimeters (Figure 1).

Daily average temperature and wind speed data for July 2017 is presented in graphical form in Figure 1 and provides context to the trends observed in the high volume air sampler (HVAS) and the standard dust deposition gauges (SDDG). The prevailing wind direction for July 2017 was North-Northeast.

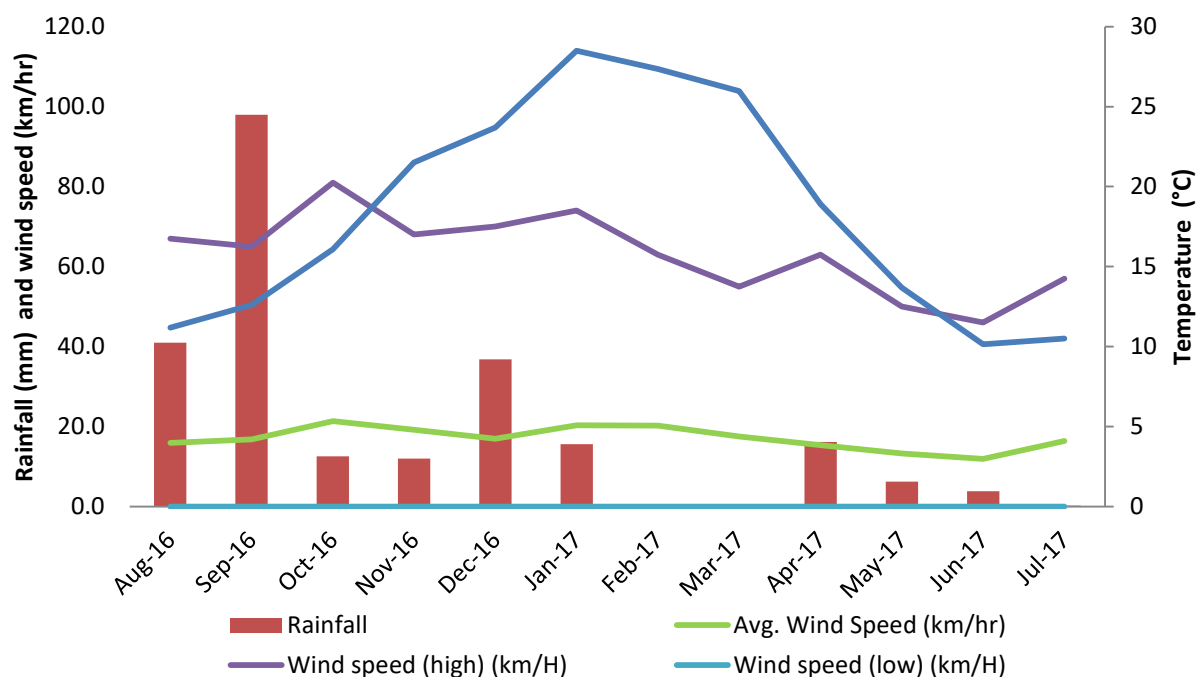
Figure 2. Average monthly temperature, wind speed and total rainfall for the 12 months up to and including July 2017.

The average temperature, average wind speed, highest and lowest wind speed and total rainfall for the previous 12 month period is depicted in Figure 2.
