Licensee	Perilya Broken Hill Limited (PBHL)
Address	Wentworth Rd, Broken Hill, NSW, 2880.
Reporting period	June 2017
Date report published on website

Meteorological Summary

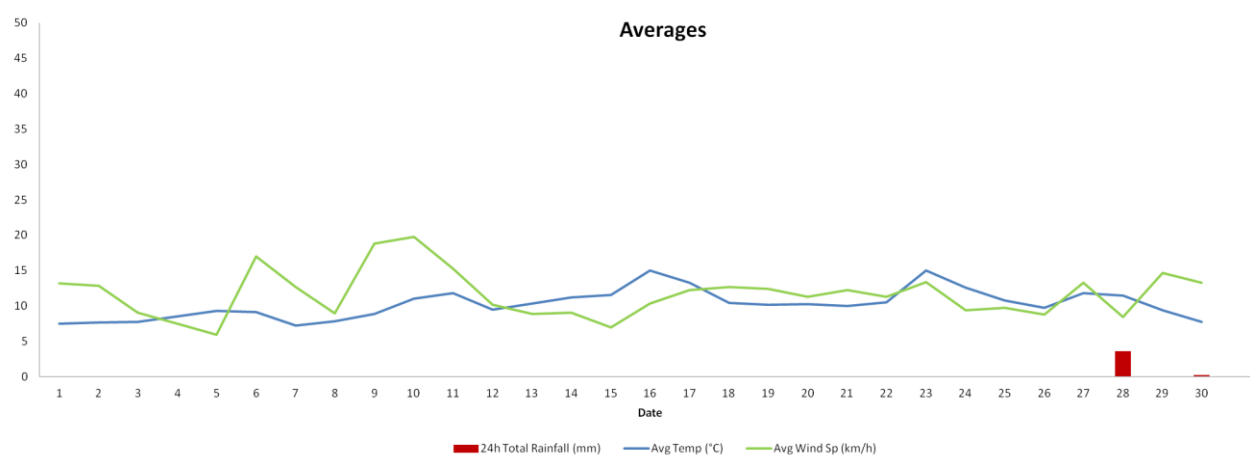
Figure 1. Average wind speed (km/hr) and daily rainfall (mm) for June 2017.

A summary of the average daily weather observations collected at Broken Hill is provided in Table 1. Total rainfall in June was 3.80 millimeters (Figure1).

Daily average temperature and wind speed data for June 2017 is presented in graphical form in Figure 1 and provides context to the trends observed in the high volume air sampler (HVAS) and the standard dust deposition gauges (SDDG). The prevailing wind direction for June 2017 was south.

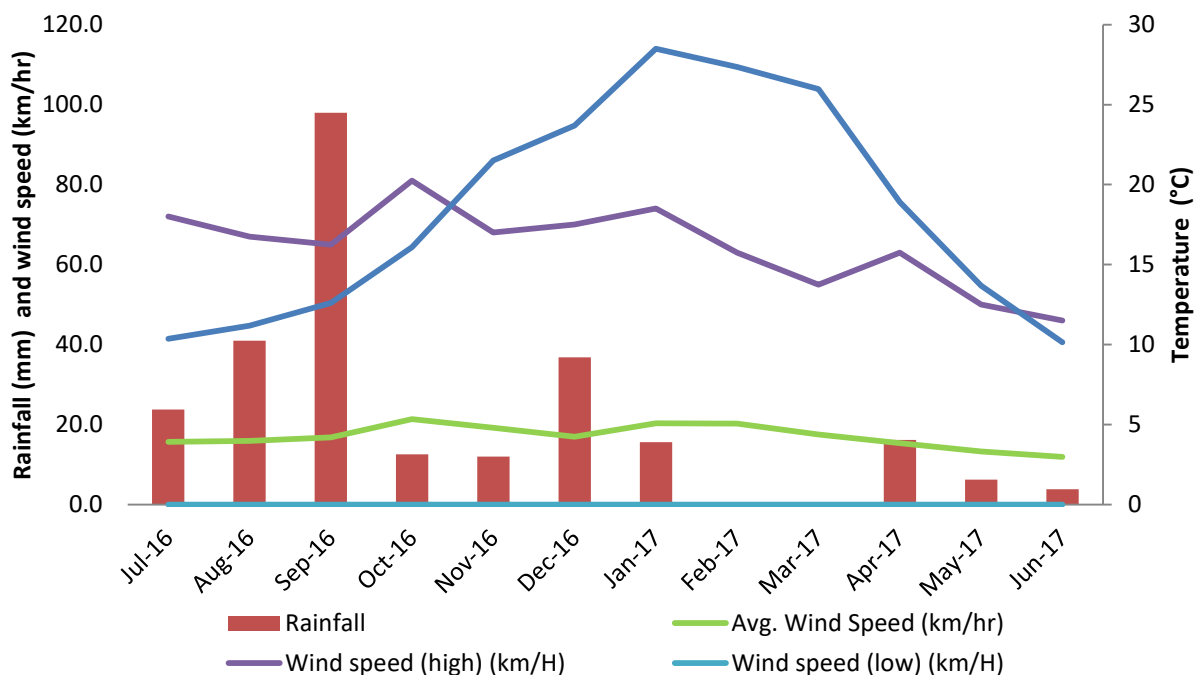
Figure 2. Average monthly temperature, wind speed and total rainfall for the 12 months up to and including June 2017.

The average temperature, average wind speed, highest and lowest wind speed and total rainfall for the previous 12 month period is depicted in Figure 2.
