Licensee	Perilya Broken Hill Limited (PBHL)
Address	Wentworth Rd, Broken Hill, NSW, 2880.
Reporting period	June 2018
Date report published on website

Meteorological Summary

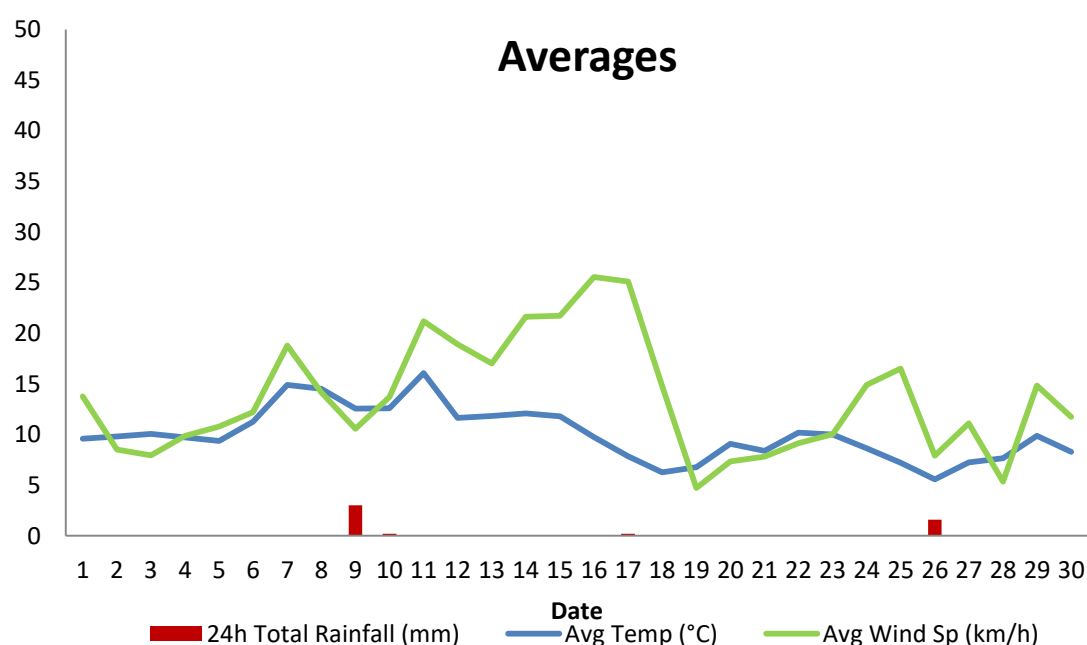
Figure 1. Average wind speed (km/hr) and daily rainfall (mm) for June 2018.

A summary of the average daily weather observations collected at Broken Hill is provided in Table 1. Total rainfall in June was 5.00 millimeters (Figure 1).

Daily average temperature and wind speed data for June 2018 is presented in graphical form in Figure 1 and provides context to the trends observed in the high volume air sampler (HVAS) and the standard dust deposition gauges (SDDG). The prevailing wind direction for June 2018 was south.

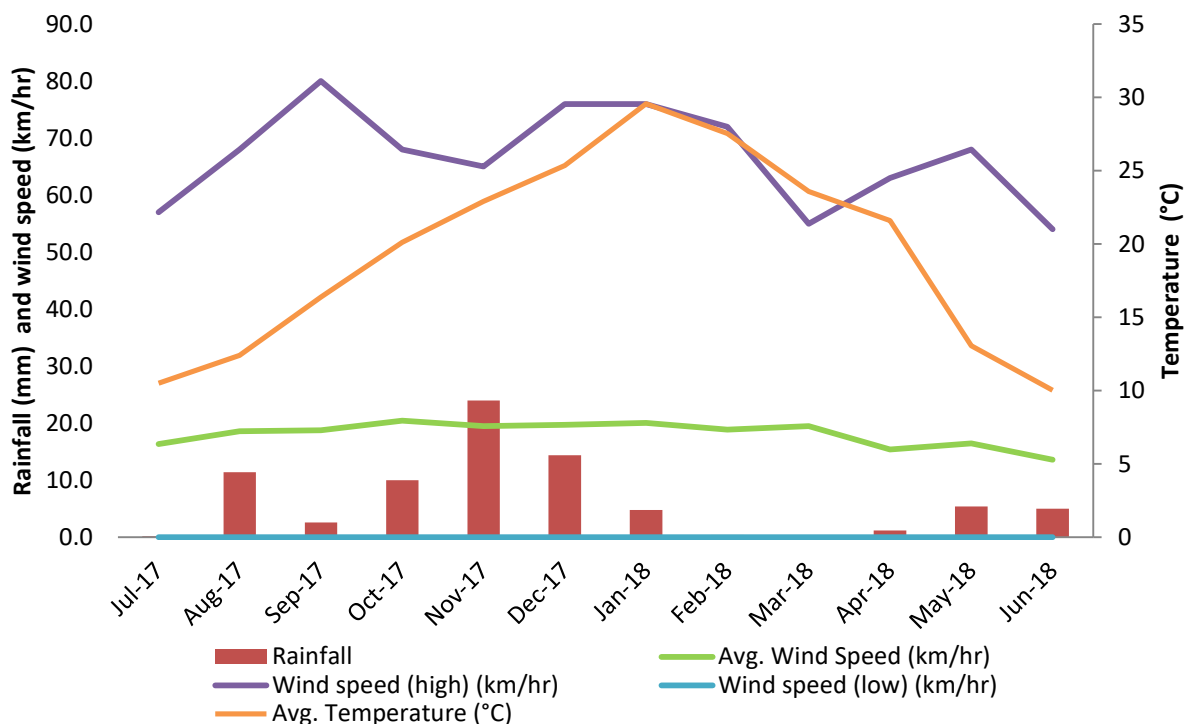
Figure 2. Average monthly temperature, wind speed and total rainfall for the 12 months up to and including June 2018.

The average temperature, average wind speed, highest and lowest wind speed and total rainfall for the previous 12 month period is depicted in Figure 2.
