Licensee	Perilya Broken Hill Limited (PBHL)
Address	Wentworth Rd, Broken Hill, NSW, 2880.
Reporting period	May 2017
Date report published on website

Meteorological Summary

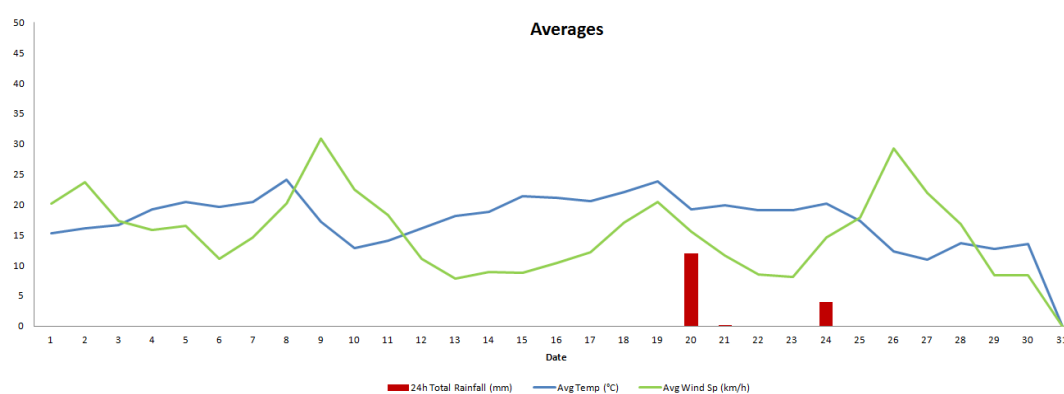
Daily average temperature and wind speed data for May 2017 is presented in graphical form in Figure 1 and provides context to the trends observed in the high volume air sampler (HVAS) and the standard dust deposition gauges (SDDG). The prevailing wind direction for May 2017 was south.

Figure 1. Average wind speed (km/hr) and daily rainfall (mm) for May 2017.

A summary of the average daily weather observations collected at Broken Hill is provided in Table 1. Total rainfall in May was 6.20 millimeters (Figure1).

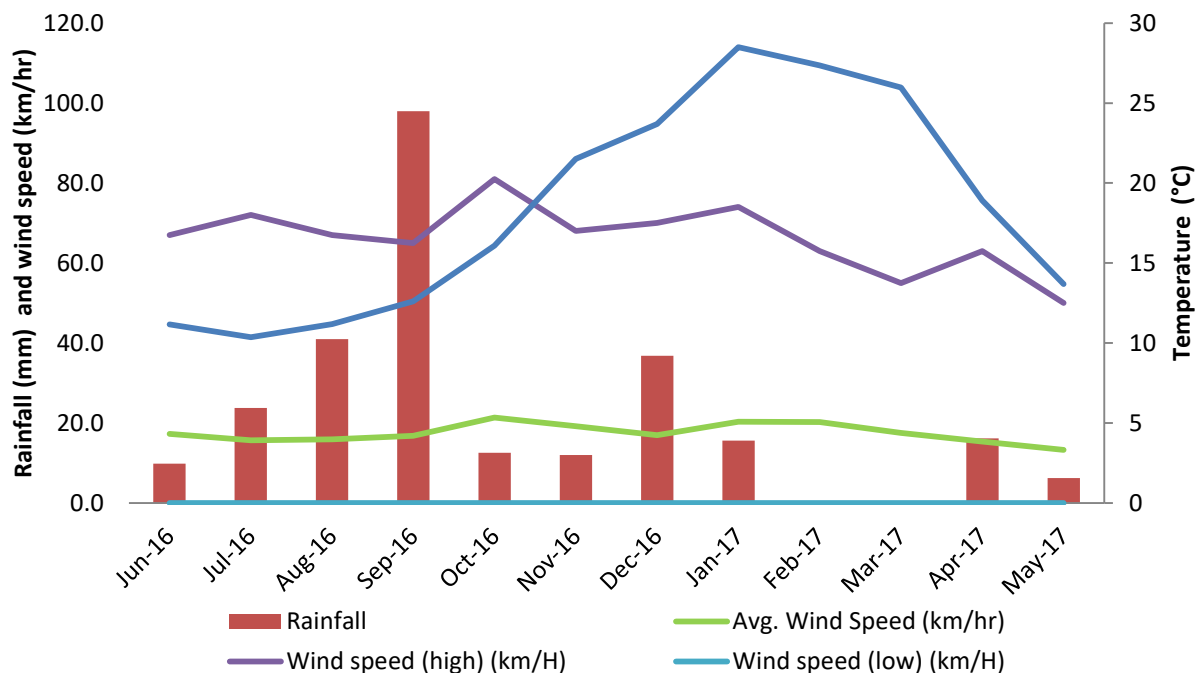
The average temperature, average wind speed, highest and lowest wind speed and total rainfall for the previous 12 month period is depicted in Figure 2.

Figure 2. Average monthly temperature, wind speed and total rainfall for the 12 months up to and including May 2017.
