Licensee	Perilya Broken Hill Limited (PBHL)
Address	Wentworth Rd, Broken Hill, NSW, 2880.
Reporting period	November 2017
Date report published on website

Meteorological Summary

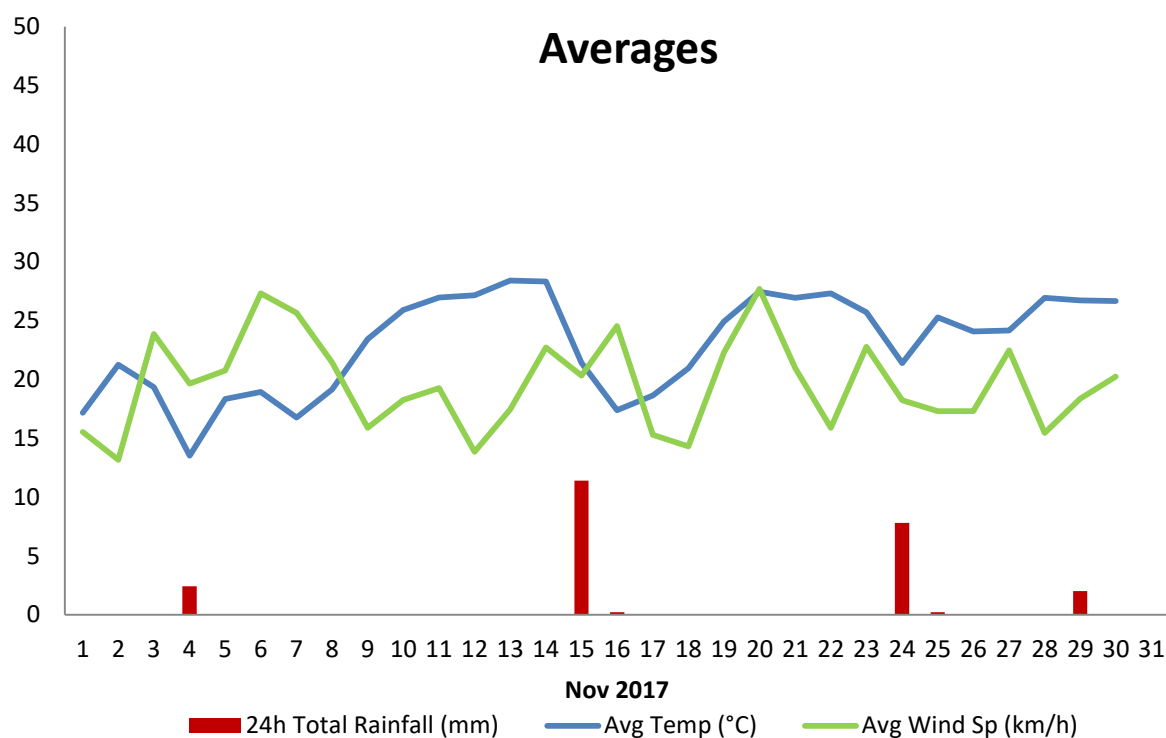
Figure 1. Average wind speed (km/hr) and daily rainfall (mm) for November 2017.

A summary of the average daily weather observations collected at Broken Hill is provided in Table 1. Total rainfall in November was 10.0 millimeters (Figure 1).

Daily average temperature and wind speed data for November 2017 is presented in graphical form in Figure 1 and provides context to the trends observed in the high volume air sampler (HVAS) and the standard dust deposition gauges (SDDG). The prevailing wind direction for November 2017 was South.

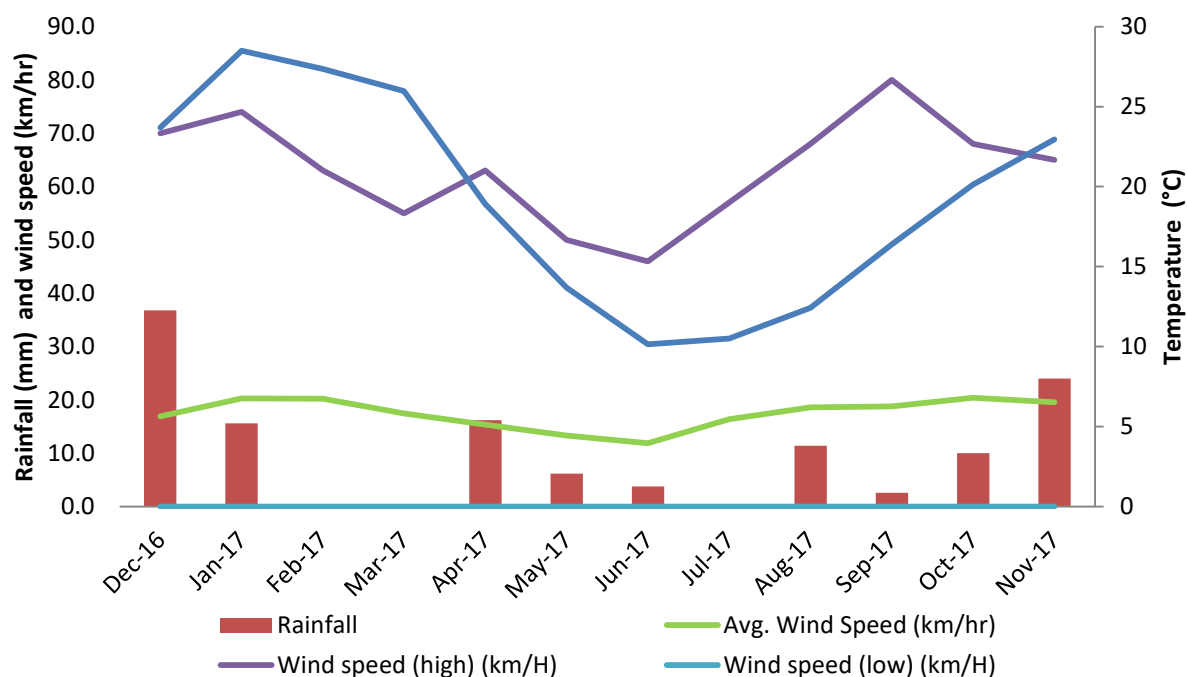
Figure 2. Average monthly temperature, wind speed and total rainfall for the 12 months up to and including November 2017.

The average temperature, average wind speed, highest and lowest wind speed and total rainfall for the previous 12 month period is depicted in Figure 2.
