Licensee	Perilya Broken Hill Limited (PBHL)
Address	Wentworth Rd, Broken Hill, NSW, 2880.
Reporting period	September 2017
Date report published on website

Meteorological Summary

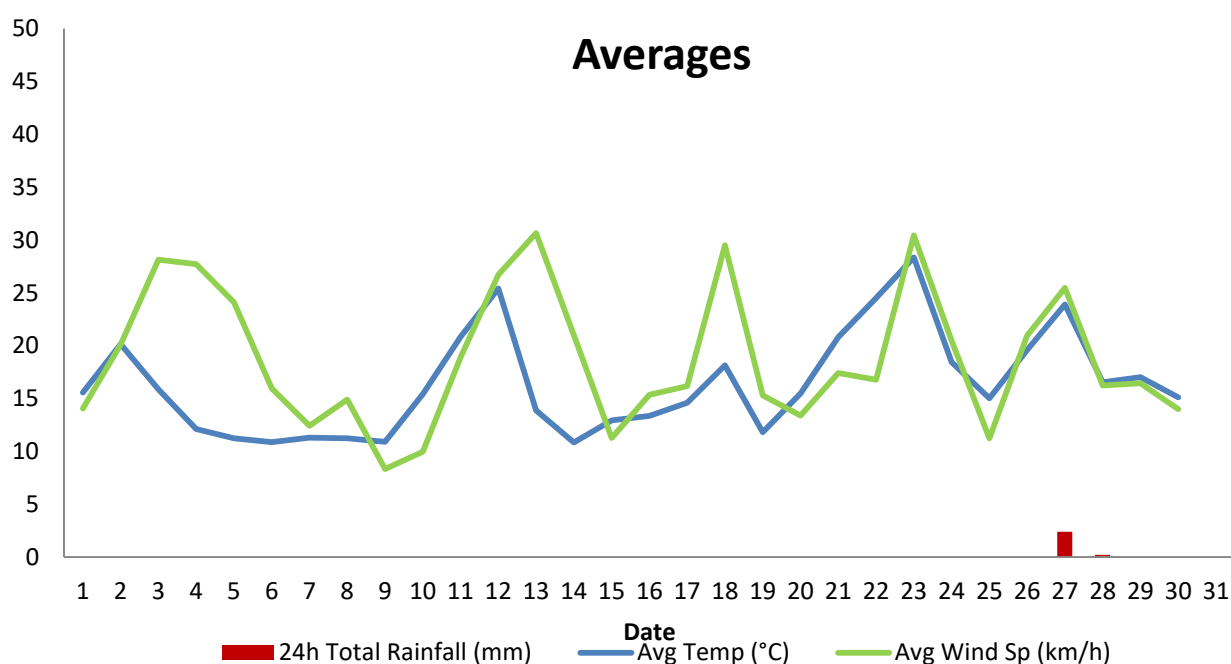
Figure 1. Average wind speed (km/hr) and daily rainfall (mm) for September 2017.

A summary of the average daily weather observations collected at Broken Hill is provided in Table 1. Total rainfall in September was 2.60 millimeters (Figure 1).

Daily average temperature and wind speed data for September 2017 is presented in graphical form in Figure 1 and provides context to the trends observed in the high volume air sampler (HVAS) and the standard dust deposition gauges (SDDG). The prevailing wind direction for September 2017 was North.

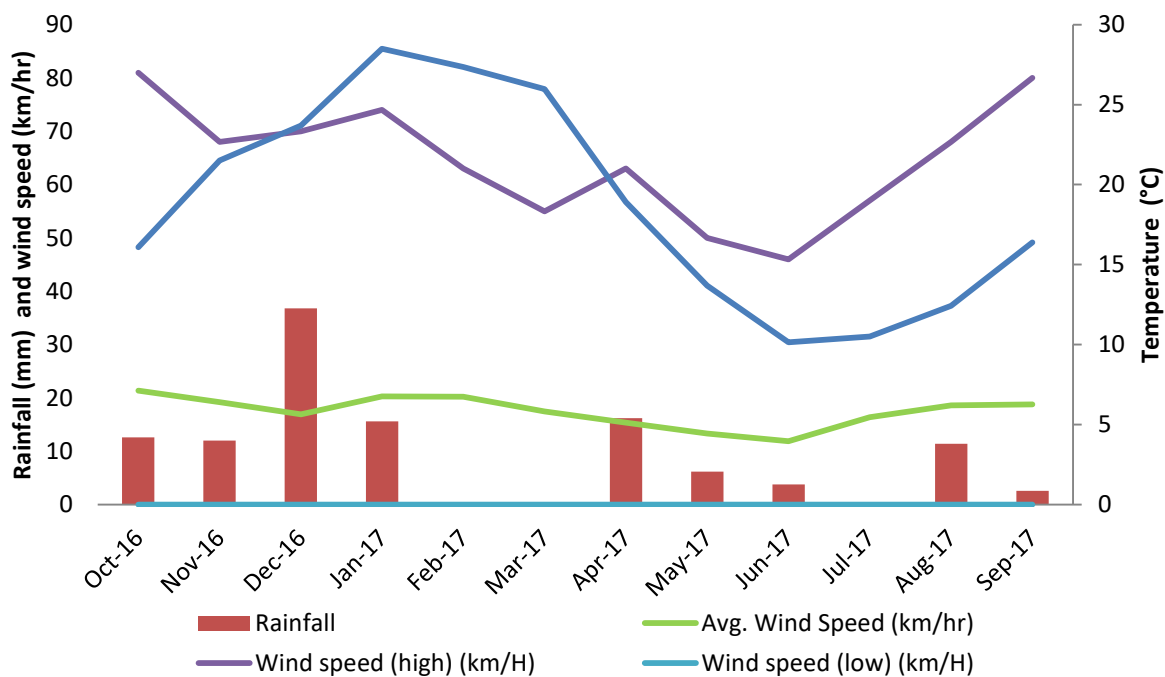
Figure 2. Average monthly temperature, wind speed and total rainfall for the 12 months up to and including September 2017.

The average temperature, average wind speed, highest and lowest wind speed and total rainfall for the previous 12 month period is depicted in Figure 2.
