<b>Licensee</b>	Perilya Broken Hill Limited (PBHL)
<b>Address</b>	Wentworth Rd, Broken Hill, NSW, 2880.
<b>Reporting period</b>	September 2018
<b>Date report published on website</b>

## Meteorological Summary

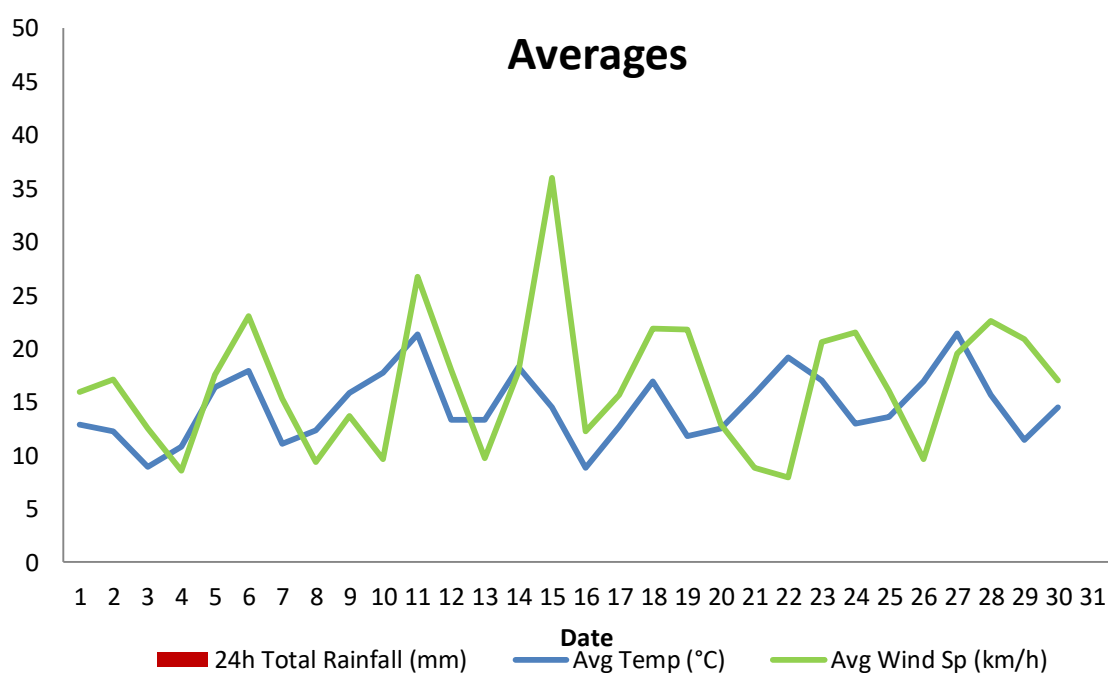
**Figure 1.** Average wind speed (km/hr) and daily rainfall (mm) for September 2018.

A summary of the average daily weather observations collected at Broken Hill is provided in Table 1. Total rainfall in September was 0.00 millimeters (Figure 1).

Daily average temperature and wind speed data for September 2018 is presented in graphical form in Figure 1 and provides context to the trends observed in the high volume air sampler (HVAS) and the standard dust deposition gauges (SDDG). The prevailing wind direction for September 2018 was South.

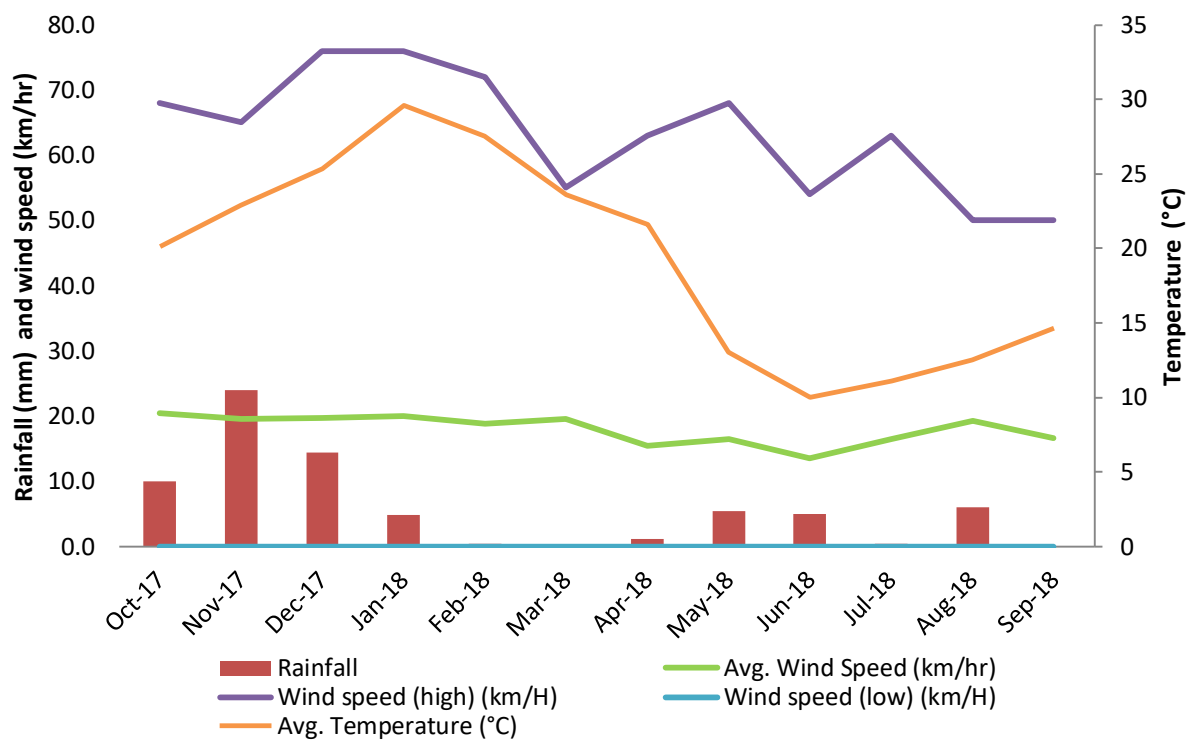
**Figure 2.** Average monthly temperature, wind speed and total rainfall for the 12 months up to and including September 2018.

The average temperature, average wind speed, highest and lowest wind speed and total rainfall for the previous 12 month period is depicted in Figure 2.
