Licensee	Perilya Broken Hill Limited (PBHL)
Address	Wentworth Rd, Broken Hill, NSW, 2880.
Environmental Protection Licence	2688 (Southern Operations)
Link to Environmental Protection Licence	http://www.epa.nsw.gov.au/prpoeoapp/ViewPOEOLicence.aspx?DOCID=31560&SYSUID=1&LICID=2688

Environmental Protection Licence 2688

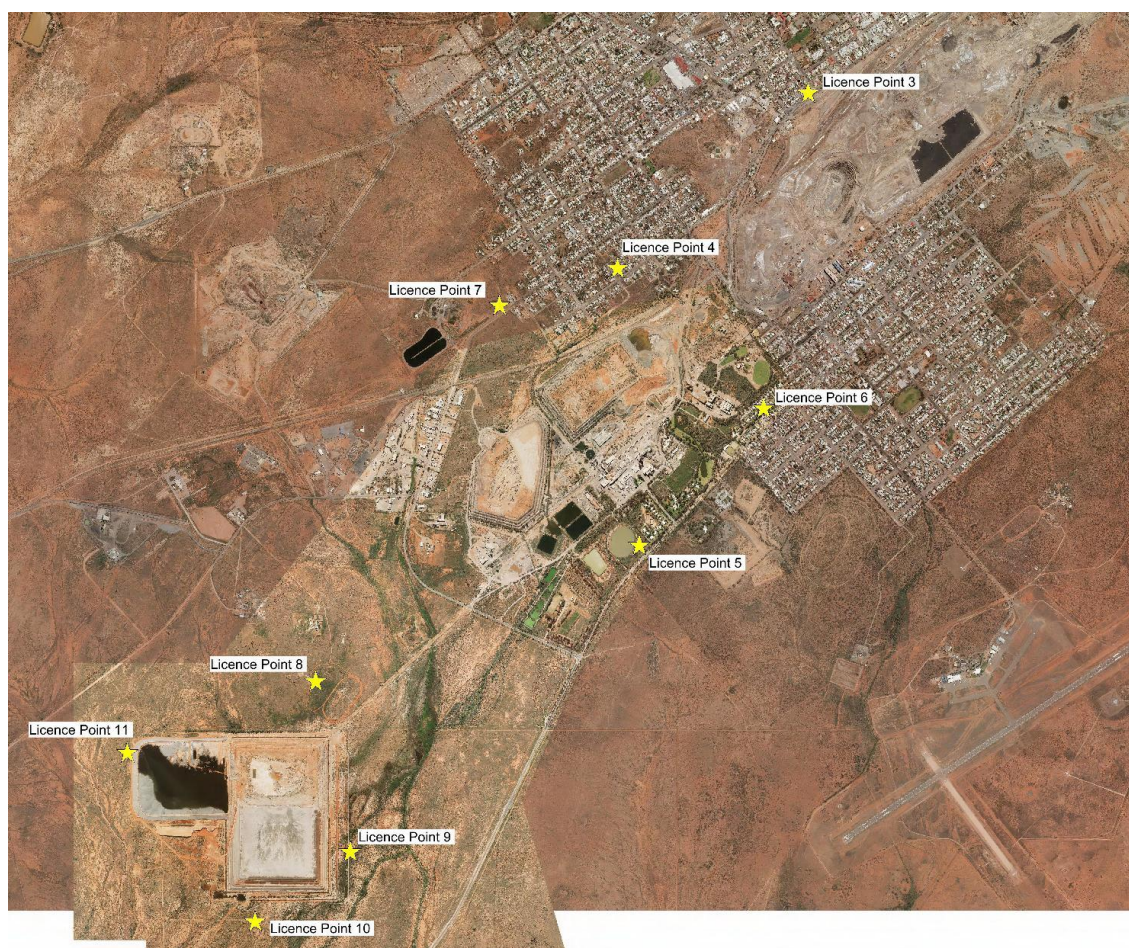
Figure 1. Location of the EPL 2688 dust monitoring points associated with Perilya's Southern Operations.

Perilya Broken Hill Limited (PBHL) has nine (9) deposited particulates monitoring points located around the Southern Operations site (Figure 1). A summary of Environmental Protection Licence (EPL) 2688 conditions is shown in Table 1.

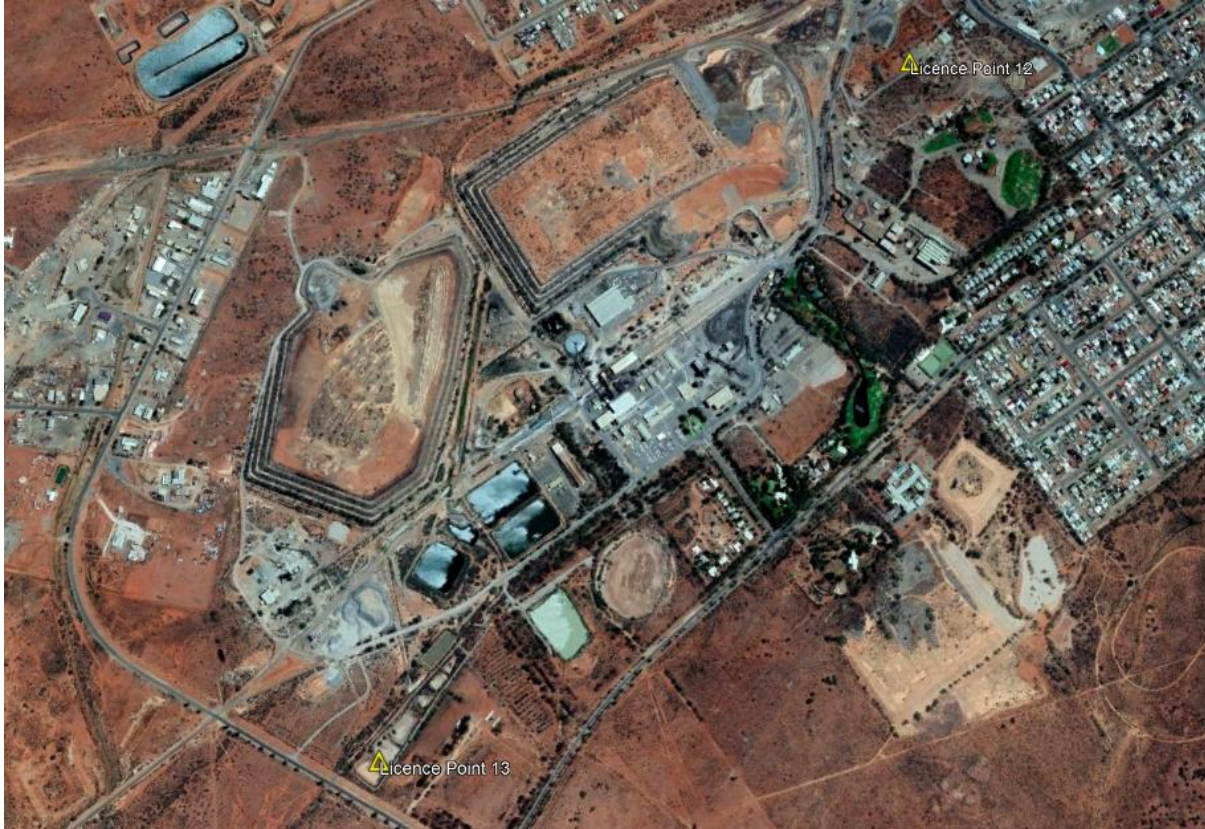
Figure 2 Locations of the ambient air monitoring points associated with EPL 2688.

EPL 2688 requires two (2) ambient air monitoring sites, both located on the Southern Operations lease (Figure 2). PBHL currently uses high volume air samplers (HVAS) for the ambient air monitoring program. The HVAS operate (sample) for 24 hours every six (6) days.

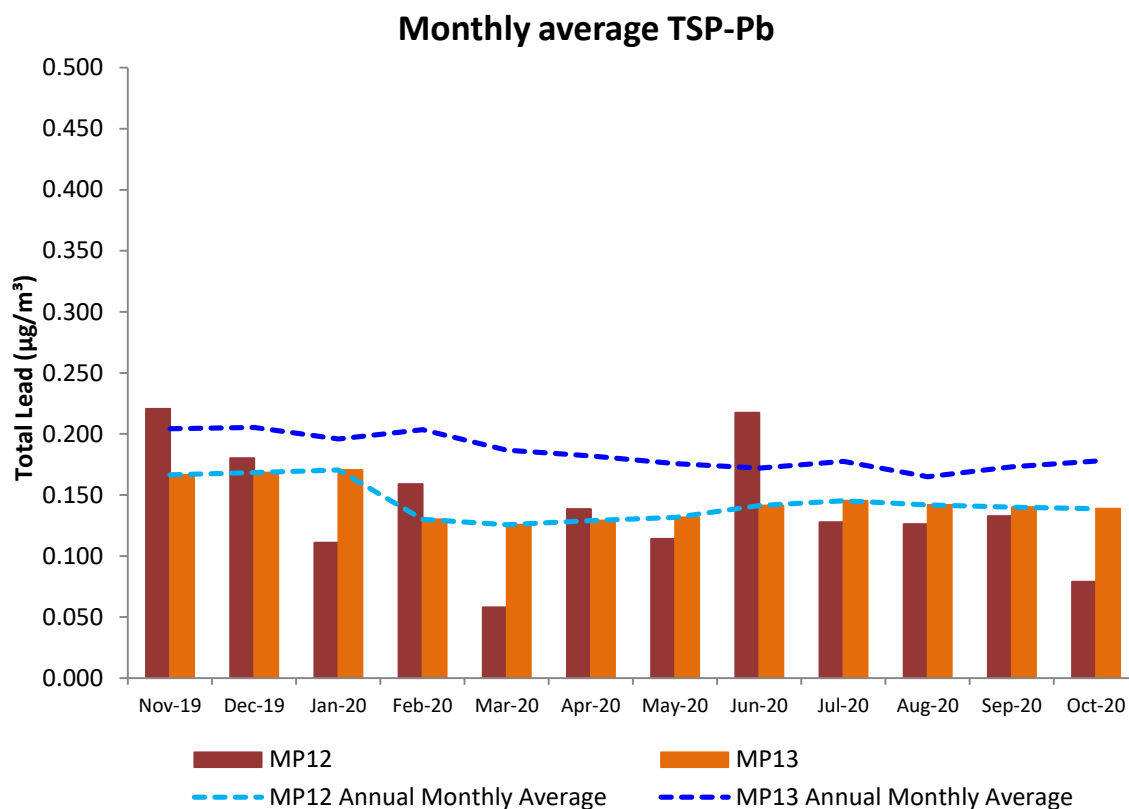
Figure 4 Average TSP-Pb results for the 12 months up to and including October 2020.

TSP and TSP-Pb results are presented in Table 4. Monthly averages for TSP and TSP-Pb for the previous 12 months are shown in Figure 3 and Figure 4 respectively. The final set of results for October ambient air monitoring, were received on the 13/11/2020.

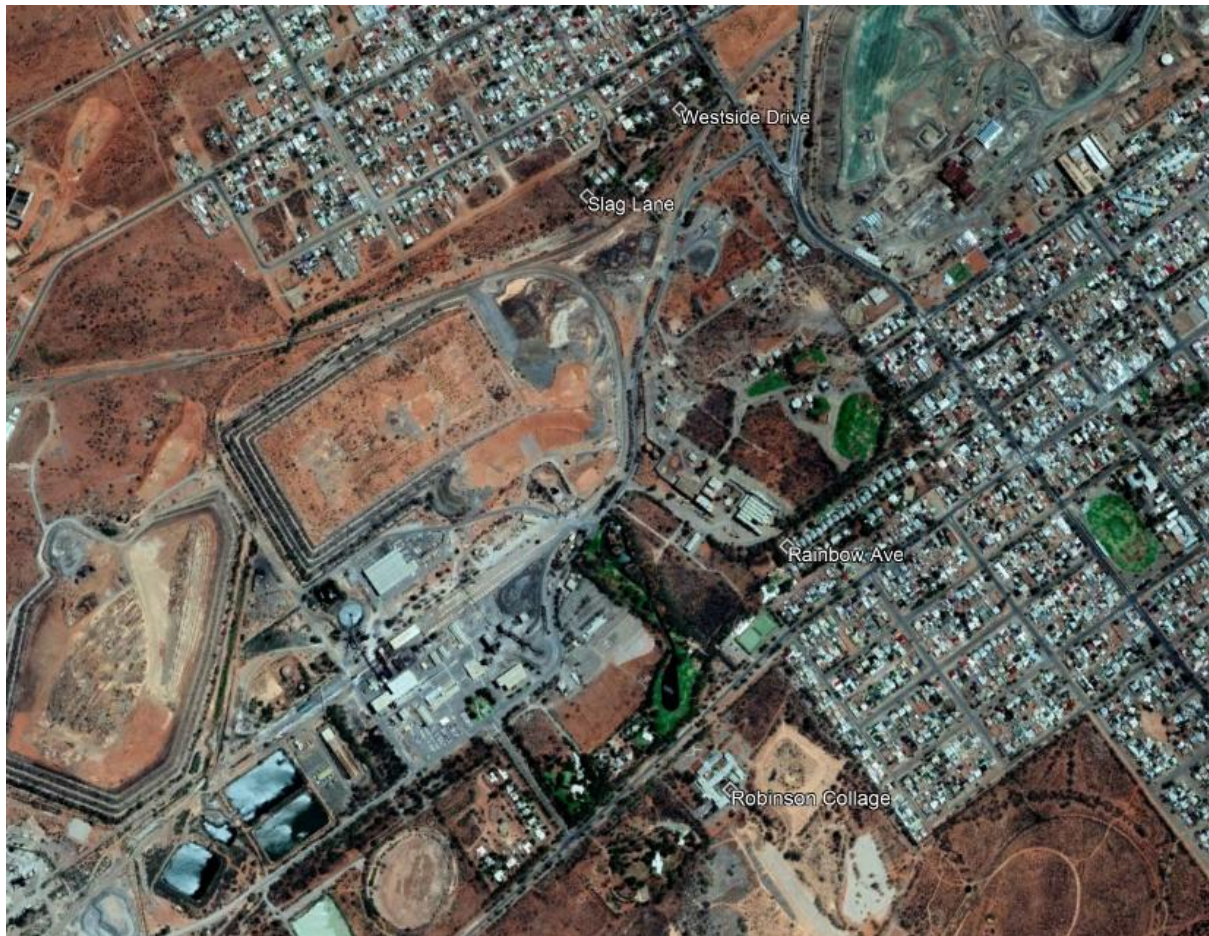
Figure 6 Location of EPL2688 blast monitors

PBHL has four (4) blast and vibration monitors associated with the Southern Operations (Figure 6). A summary of EPL 2688 conditions for blasting is provided in Table 6.
