Licensee	Perilya Broken Hill Limited (PBHL)
Address	Wentworth Rd, Broken Hill, NSW, 2880.
Environmental Protection Licence	2688 (Southern Operations)
Link to Environmental Protection Licence	http://www.epa.nsw.gov.au/prpoeoapp/ViewPOEOLicence.aspx?DOCID=31560&SYSUID=1&LICID=2688
Reporting period	August 2017
Date report published on website

Environmental Protection Licence 2688

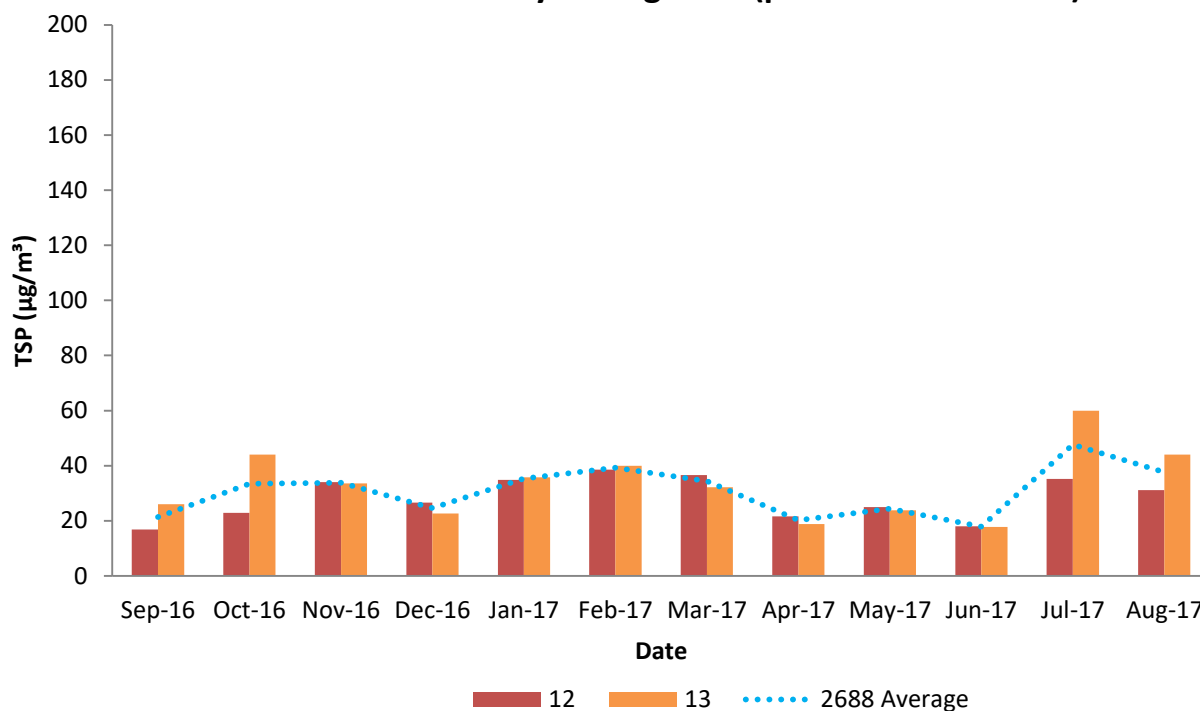
Figure 3. Average TSP results for the 12 months up to and including August.

Total suspended particulate (TSP) and total lead results are presented in Table 4. Monthly averages for TSP and total lead for the previous 12 months are shown in Figure 3 and Figure 4 respectively. The results for the HVAS monitoring were received on the 25/09/2017.

Annual monthly average TSP (previous 12 months)

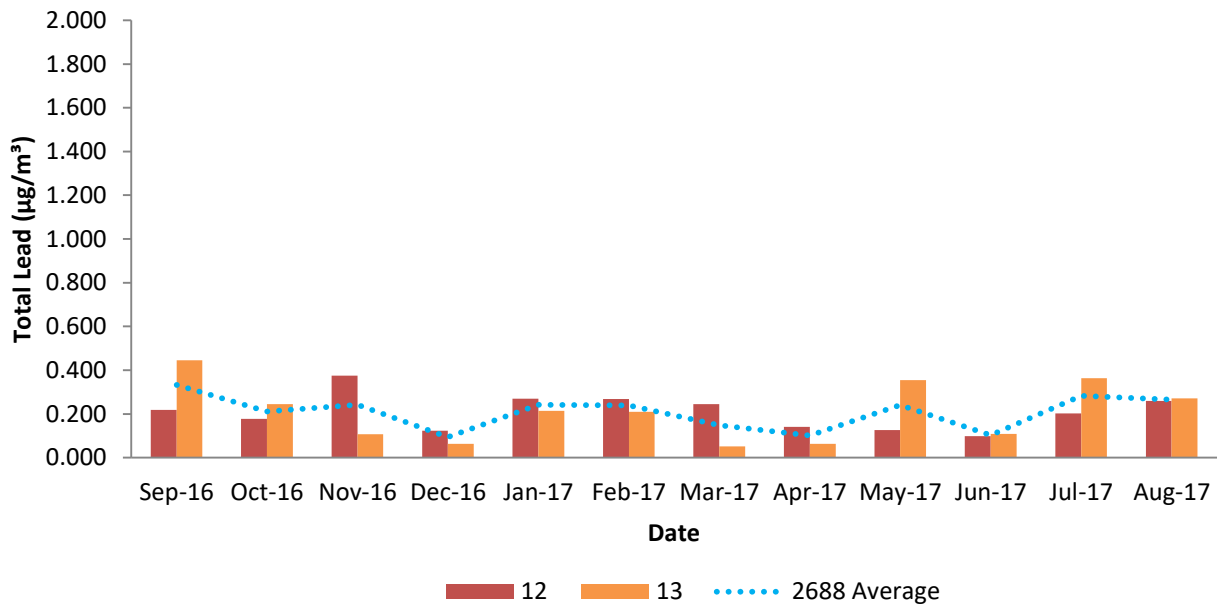
Figure 4. Average total lead results for the 12 months up to and including August.

Annual monthly Total Lead average (previous 12 months)
