Licensee	Perilya Broken Hill Limited (PBHL)
Address	Wentworth Rd, Broken Hill, NSW, 2880.
Environmental Protection Licence	2688 (Southern Operations)
Link to Environmental Protection Licence	http://www.epa.nsw.gov.au/prpoeoapp/ViewPOEOLicence.aspx?DOCID=31560&SYSUID=1&LICID=2688
Reporting period	February
Date report published on website

Environmental Protection Licence 2688

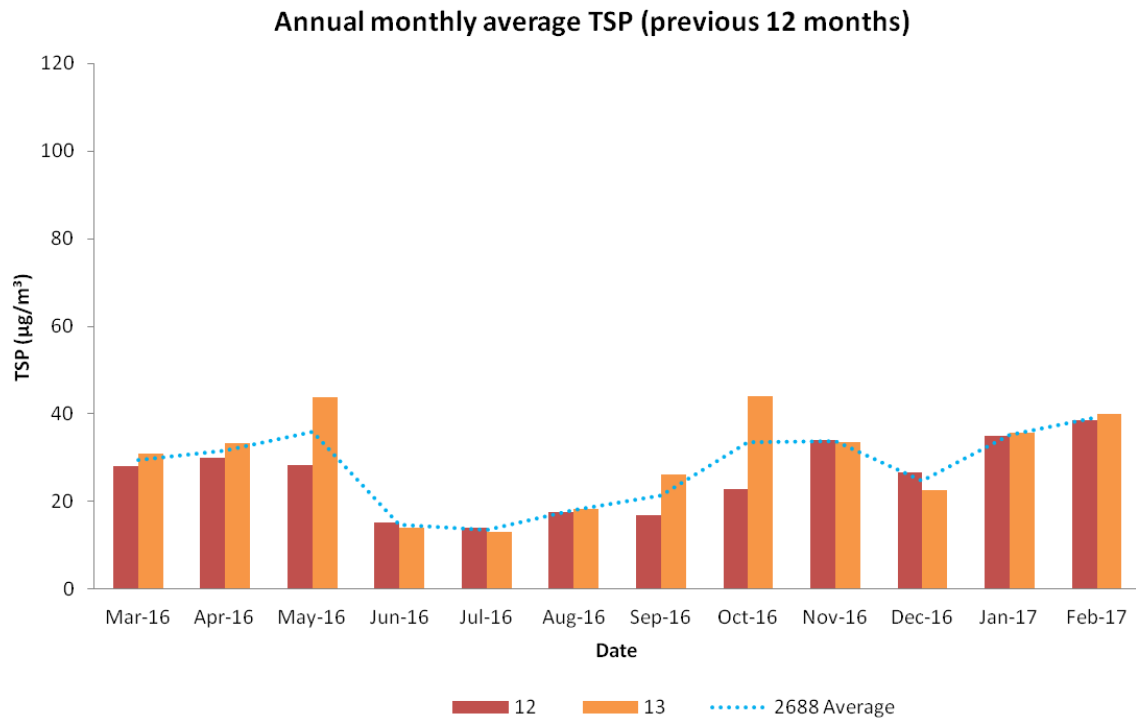
Figure 3. Average TSP results for the 12 months up to and including February.

Total suspended particulate (TSP) and total lead results are presented in Table 4. Monthly averages for TSP and total lead for the previous 12 months are shown in Figure 3 and

Licence Point	Pollutant	No. times measured in the month	Min. value	Mean Value	Median Value	Max. Value
12	TSP ($\mu\text{g}/\text{m}^3$)	5	31.0	38.6	40.0	48.0
	Total Lead ($\mu\text{g}/\text{m}^3$)	5	0.1000	0.268	0.270	0.470
13	TSP ($\mu\text{g}/\text{m}^3$)	5	27.0	40.0	33.0	67.0
	Total Lead ($\mu\text{g}/\text{m}^3$)	5	0.1200	0.210	0.140	0.440
