Licensee	Perilya Broken Hill Limited (PBHL)
Address	Wentworth Rd, Broken Hill, NSW, 2880.
Environmental Protection Licence	2688 (Southern Operations)
Link to Environmental Protection Licence	http://www.epa.nsw.gov.au/prpoeoapp/ViewPOEOLicence.aspx?DOCID=31560&SYSUID=1&LICID=2688
Reporting period	July 2017
Date report published on website

Environmental Protection Licence 2688

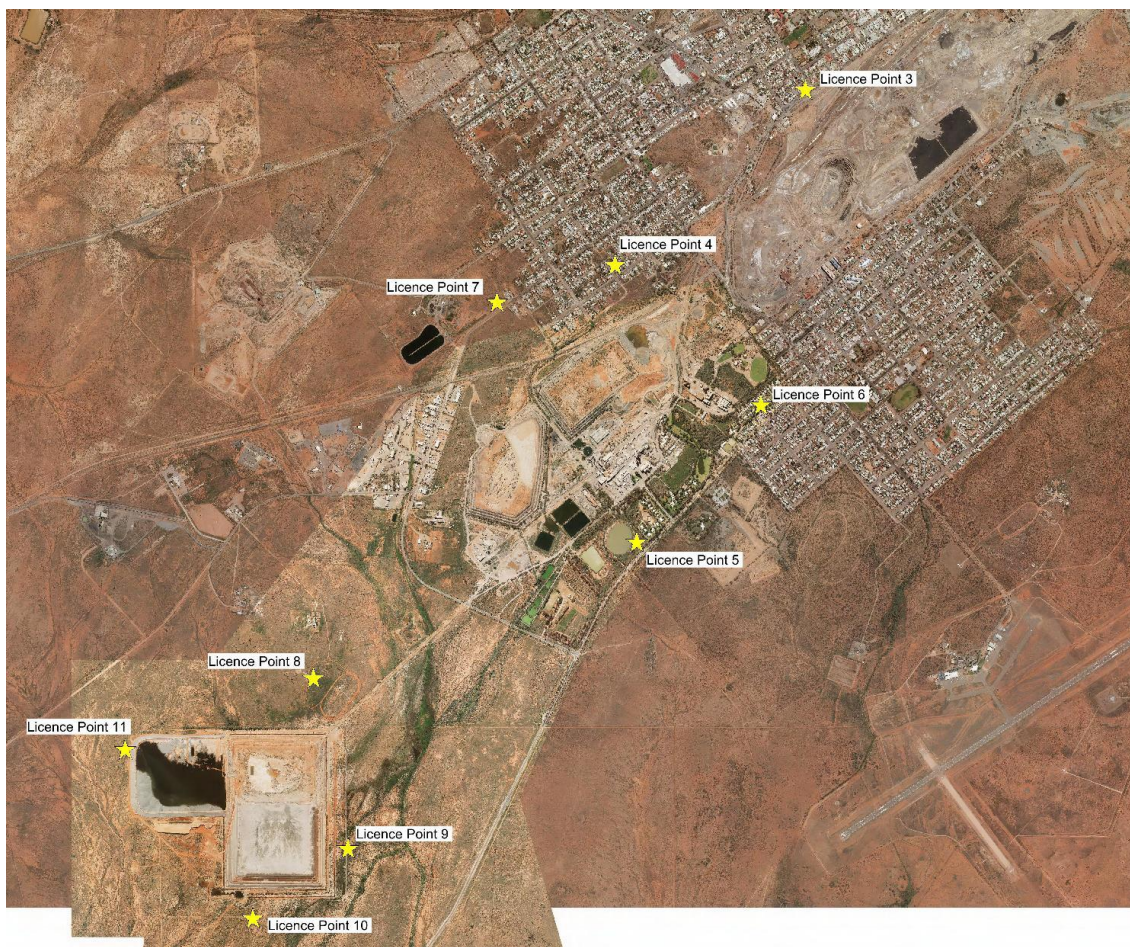
Figure 1. Location of the EPL 2688 deposition dust gauges associated with Perilya's Southern Operations.

Perilya Broken Hill Limited (PBHL) has nine (9) deposition dust gauge stations located at strategic points around the Southern Operations site (Figure 1). A summary of Environmental Protection Licence (EPL) 2688 conditions is shown in Table 1.

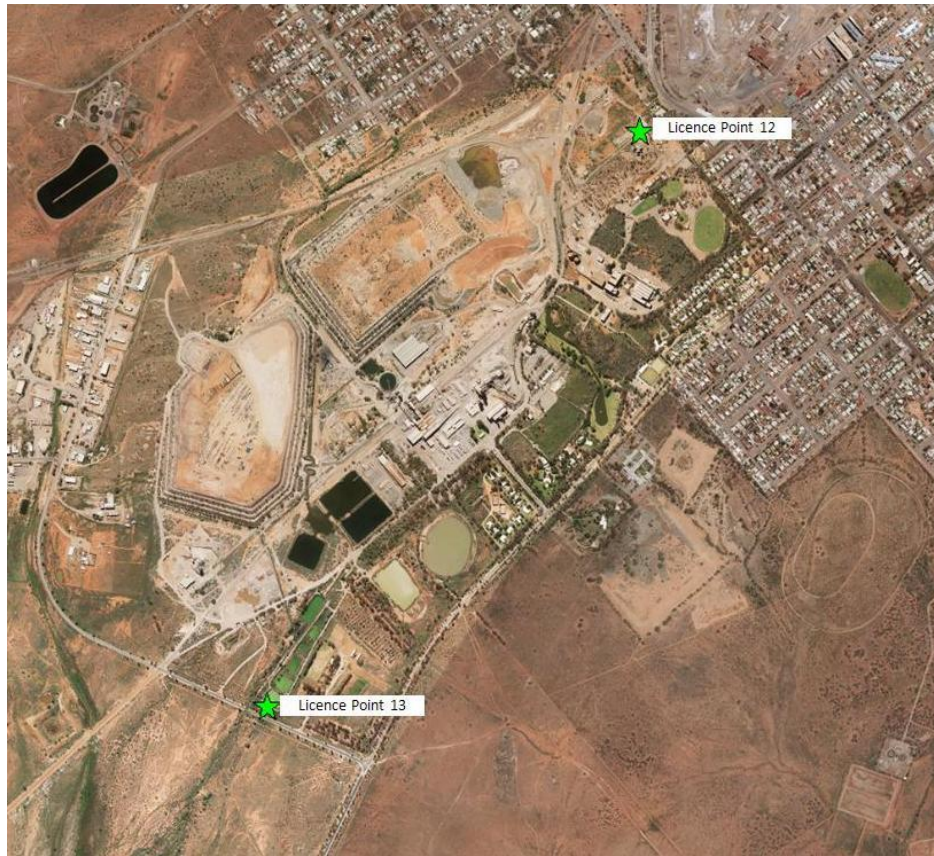
Figure 2. Location of the HVAS associated with EPL 2688.

PBHL currently operates two (2) high volume air samplers (HVAS) in relation to EPL 2688, both located at the Southern Operations site (Figure 2). HVAS sampling stations operate (sample) routinely for a 24-hour period every six (6) days on a regular basis.

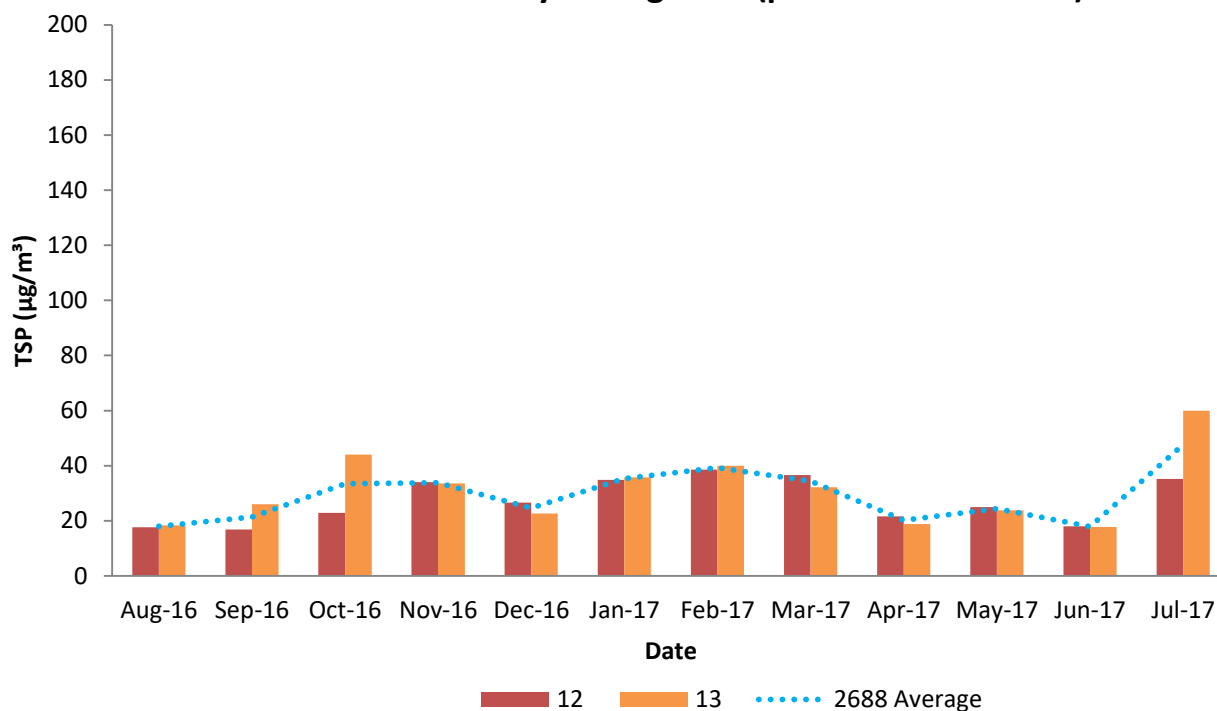
Figure 3. Average TSP results for the 12 months up to and including July.

Annual monthly average TSP (previous 12 months)

Total suspended particulate (TSP) and total lead results are presented in Table 4. Monthly averages for TSP and total lead for the previous 12 months are shown in Figure 3 and Figure 4 respectively. The results for the HVAS monitoring were received on the 31/08/2017.
