<b>Licensee</b>	Perilya Broken Hill Limited (PBHL)
<b>Address</b>	Wentworth Rd, Broken Hill, NSW, 2880.
<b>Environmental Protection Licence</b>	2688 (Southern Operations)
<b>Link to Environmental Protection Licence</b>	<a href="http://www.epa.nsw.gov.au/prpoeoapp/ViewPOEOLicence.aspx?DOCID=31560&amp;SYSUID=1&amp;LICID=2688">http://www.epa.nsw.gov.au/prpoeoapp/ViewPOEOLicence.aspx?DOCID=31560&amp;SYSUID=1&amp;LICID=2688</a>
<b>Reporting period</b>	November 2017
<b>Date report published on website</b>

## Environmental Protection Licence 2688

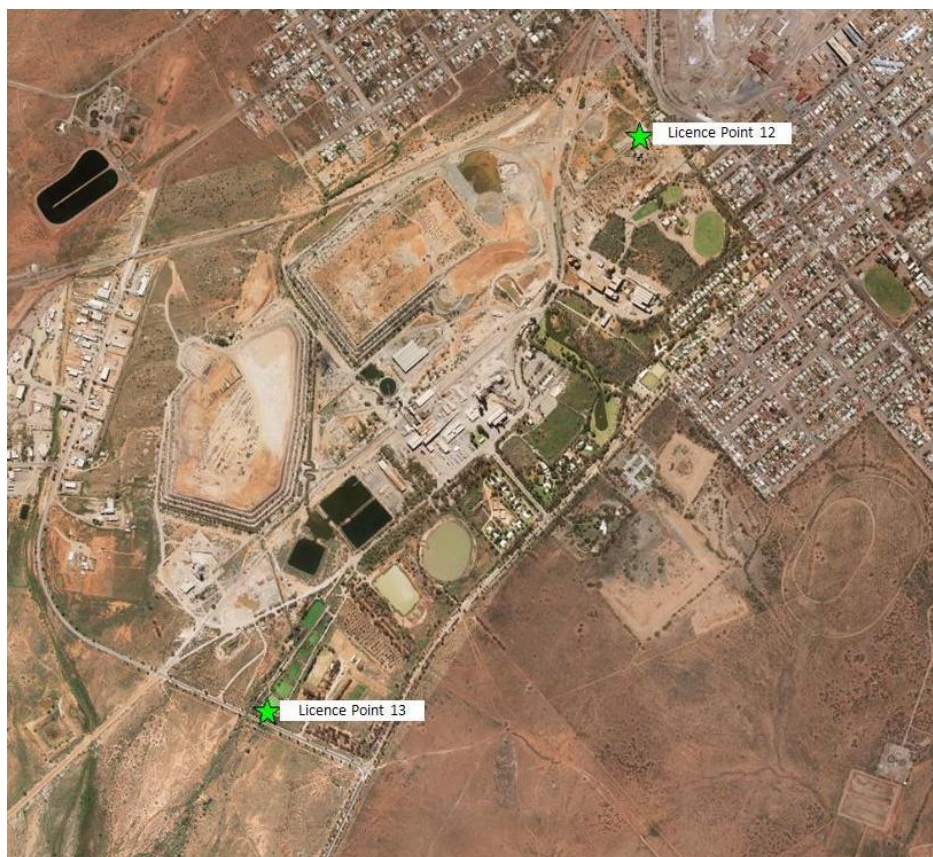
**Figure 2.** Location of the HVAS associated with EPL 2688.

PBHL currently operates two (2) high volume air samplers (HVAS) in relation to EPL 2688, both located at the Southern Operations site (Figure 2). HVAS sampling stations operate (sample) routinely for a 24-hour period every six (6) days on a regular basis.

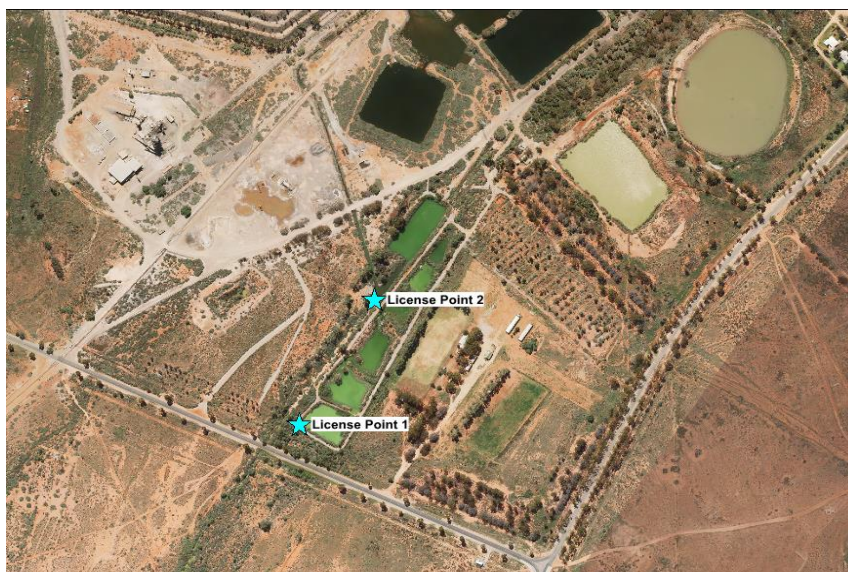
**Figure 5.** Location of the EPL2688 licenced discharge points.

PBHL has two (2) licenced discharge points for surface waters, Licence Point 1 and Licence Point 2 (Figure 5). A summary of the licence conditions relating to discharges of waters from these two points is shown in Table 5.

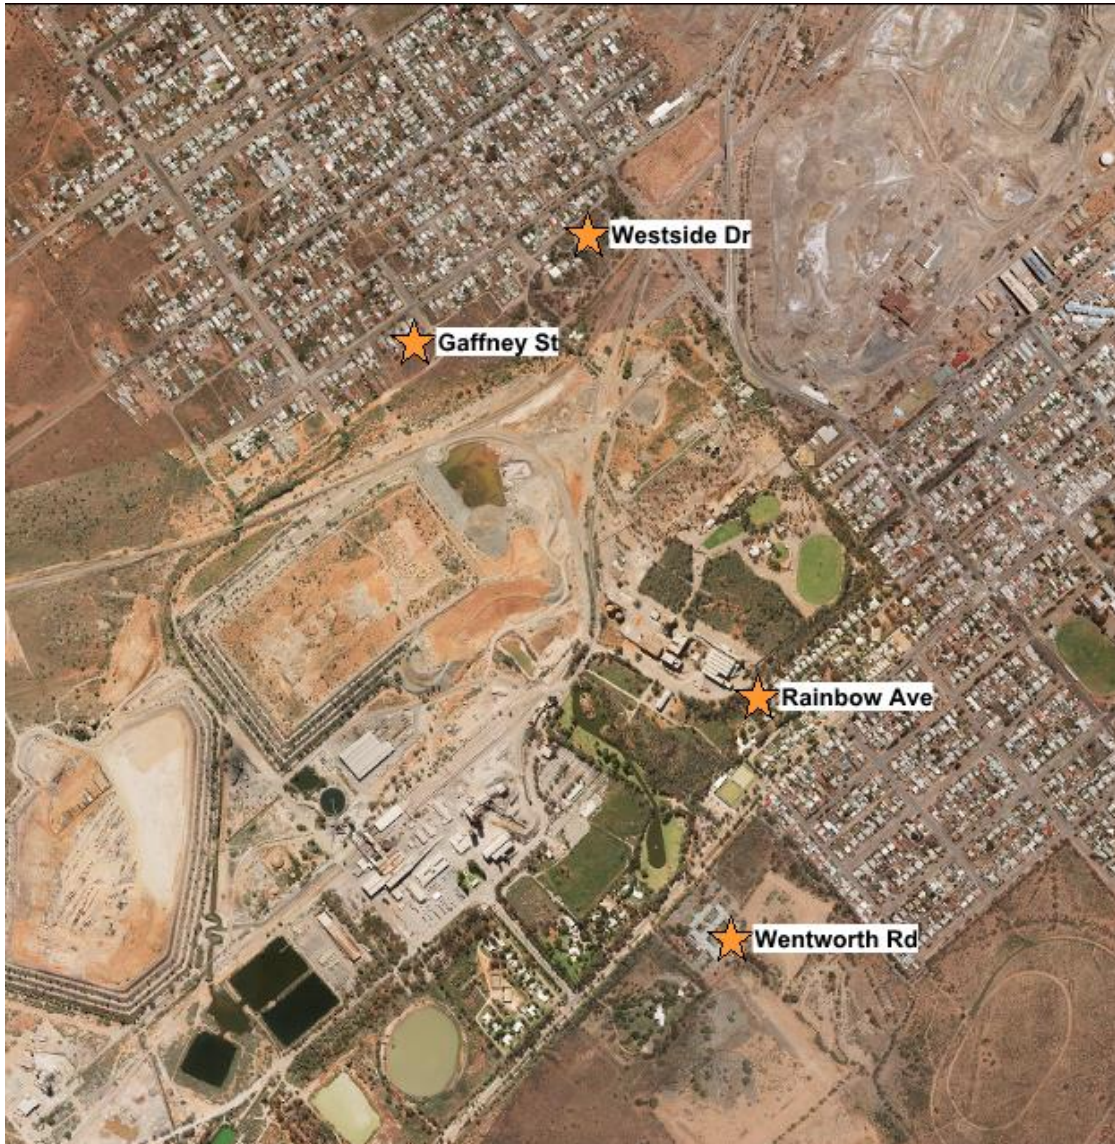
**Figure 6.** Location of EPL2688 blast monitors.

PBHL has four (4) blast monitors associated with the Southern Operations (Figure 6). A summary of EPL 2688 conditions for blasting is provided in Table 7.
