Licensee	Perilya Broken Hill Limited (PBHL)
Address	Wentworth Rd, Broken Hill, NSW, 2880.
Environmental Protection Licence	2688 (Southern Operations)
Link to Environmental Protection Licence	http://www.epa.nsw.gov.au/prpoeoapp/ViewPOEOLicence.aspx?DOCID=31560&SYSUID=1&LICID=2688
Reporting period	October 2017
Date report published on website

Environmental Protection Licence 2688

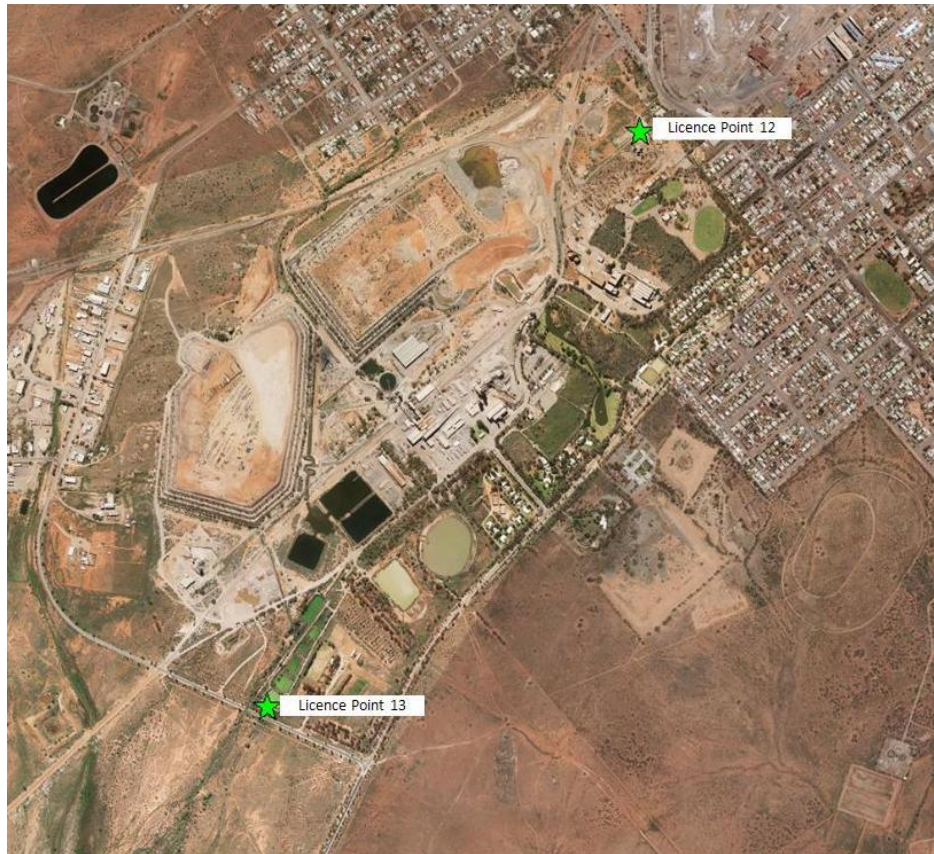
Figure 2. Location of the HVAS associated with EPL 2688.

PBHL currently operates two (2) high volume air samplers (HVAS) in relation to EPL 2688, both located at the Southern Operations site (Figure 2). HVAS sampling stations operate (sample) routinely for a 24-hour period every six (6) days on a regular basis.

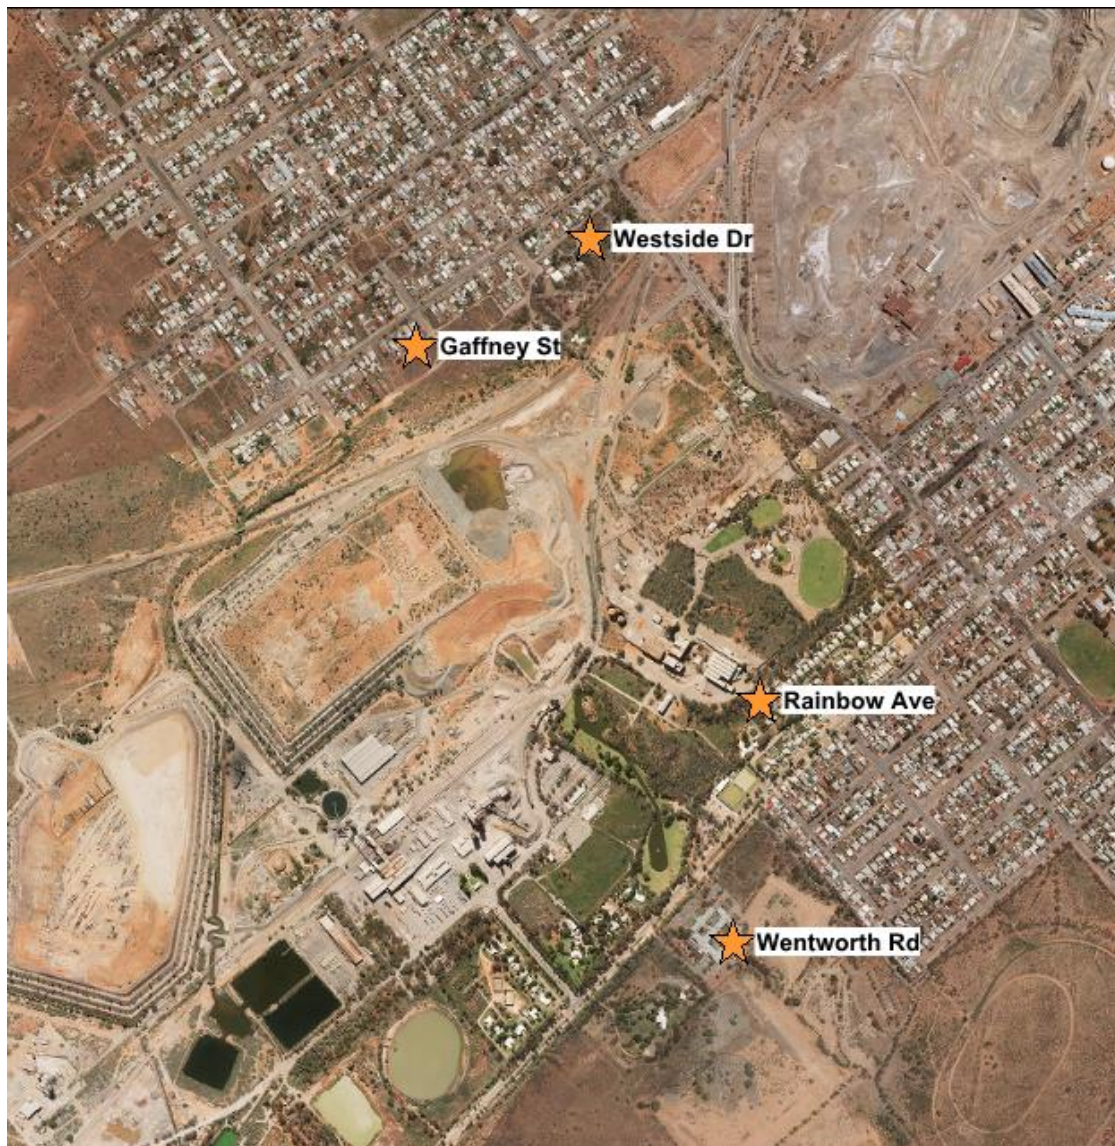
Figure 6. Location of EPL2688 blast monitors.

PBHL has four (4) blast monitors associated with the Southern Operations (Figure 6). A summary of EPL 2688 conditions for blasting is provided in Table 7.
