Licensee	Perilya Broken Hill Limited (PBHL)
Address	Wentworth Rd, Broken Hill, NSW, 2880.
Environmental Protection Licence	2688 (Southern Operations)
Link to Environmental Protection Licence	http://www.epa.nsw.gov.au/prpoeoapp/ViewPOEOLicence.aspx?DOCID=31560&SYSUID=1&LICID=2688
Reporting period	September 2017
Date report published on website

Environmental Protection Licence 2688

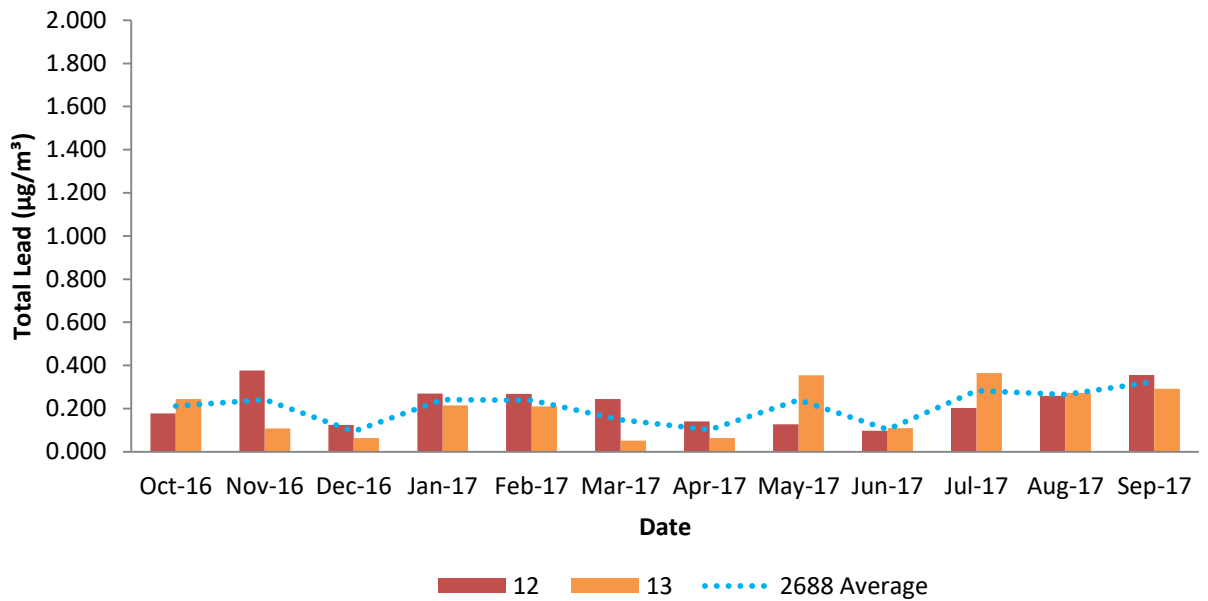
Annual monthly Total Lead average (previous 12 months)

Figure 4. Average total lead results for the 12 months up to and including September.

Total suspended particulate (TSP) and total lead results are presented in Table 4. Monthly averages for TSP and total lead for the previous 12 months are shown in Figure 3 and Figure 4 respectively. The results for the HVAS monitoring were received on the 31/10/2017.

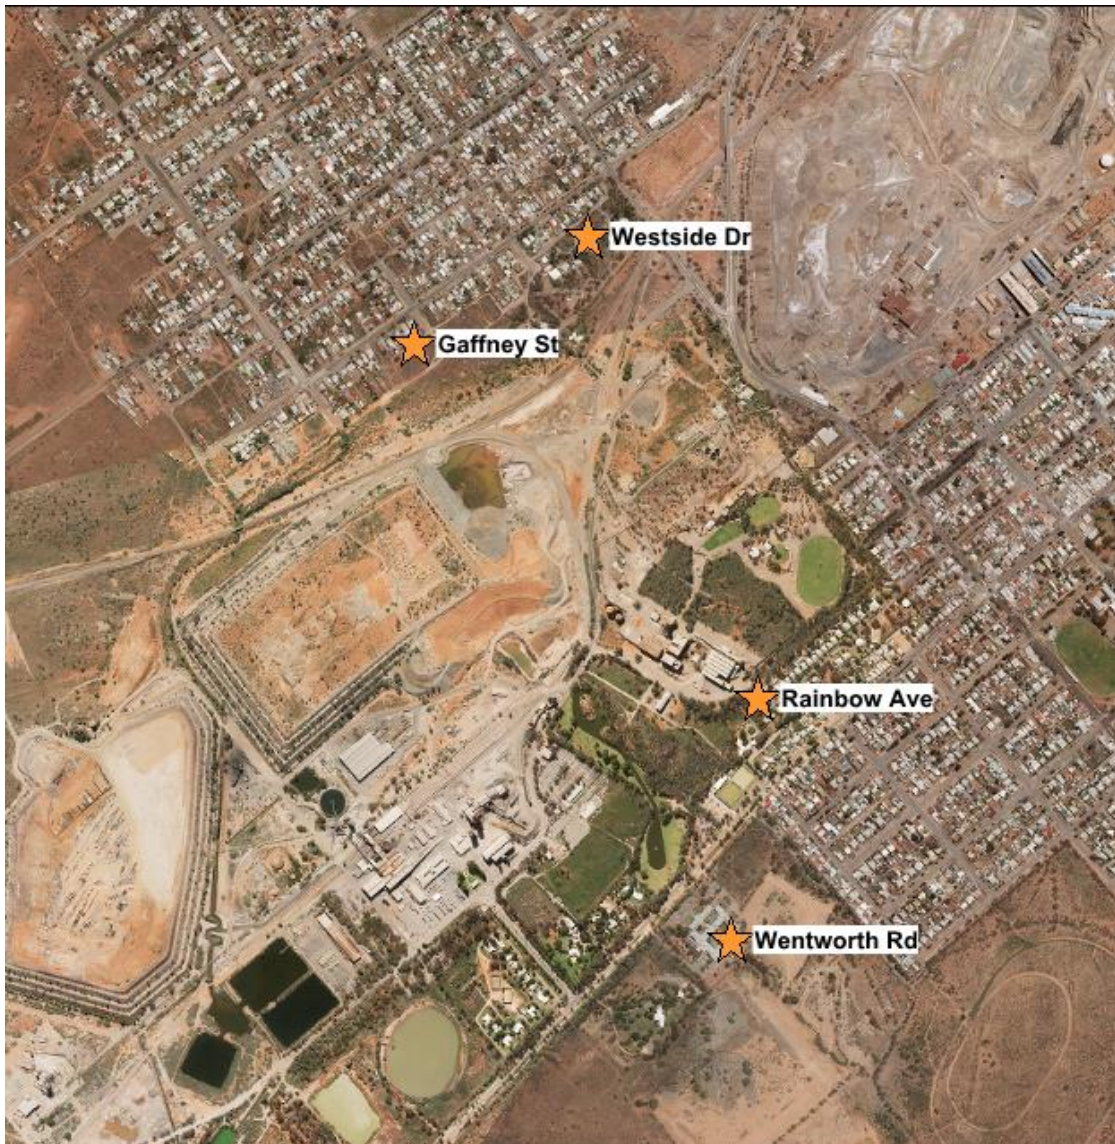
Figure 6. Location of EPL2688 blast monitors.

PBHL has four (4) blast monitors associated with the Southern Operations (Figure 6). A summary of EPL 2688 conditions for blasting is provided in Table 7.
